School Lodge, Matson

Swept path analysis of an 11m refuse vehicle

Update Ecological Appraisal

School Lodge, Matson, November 2022

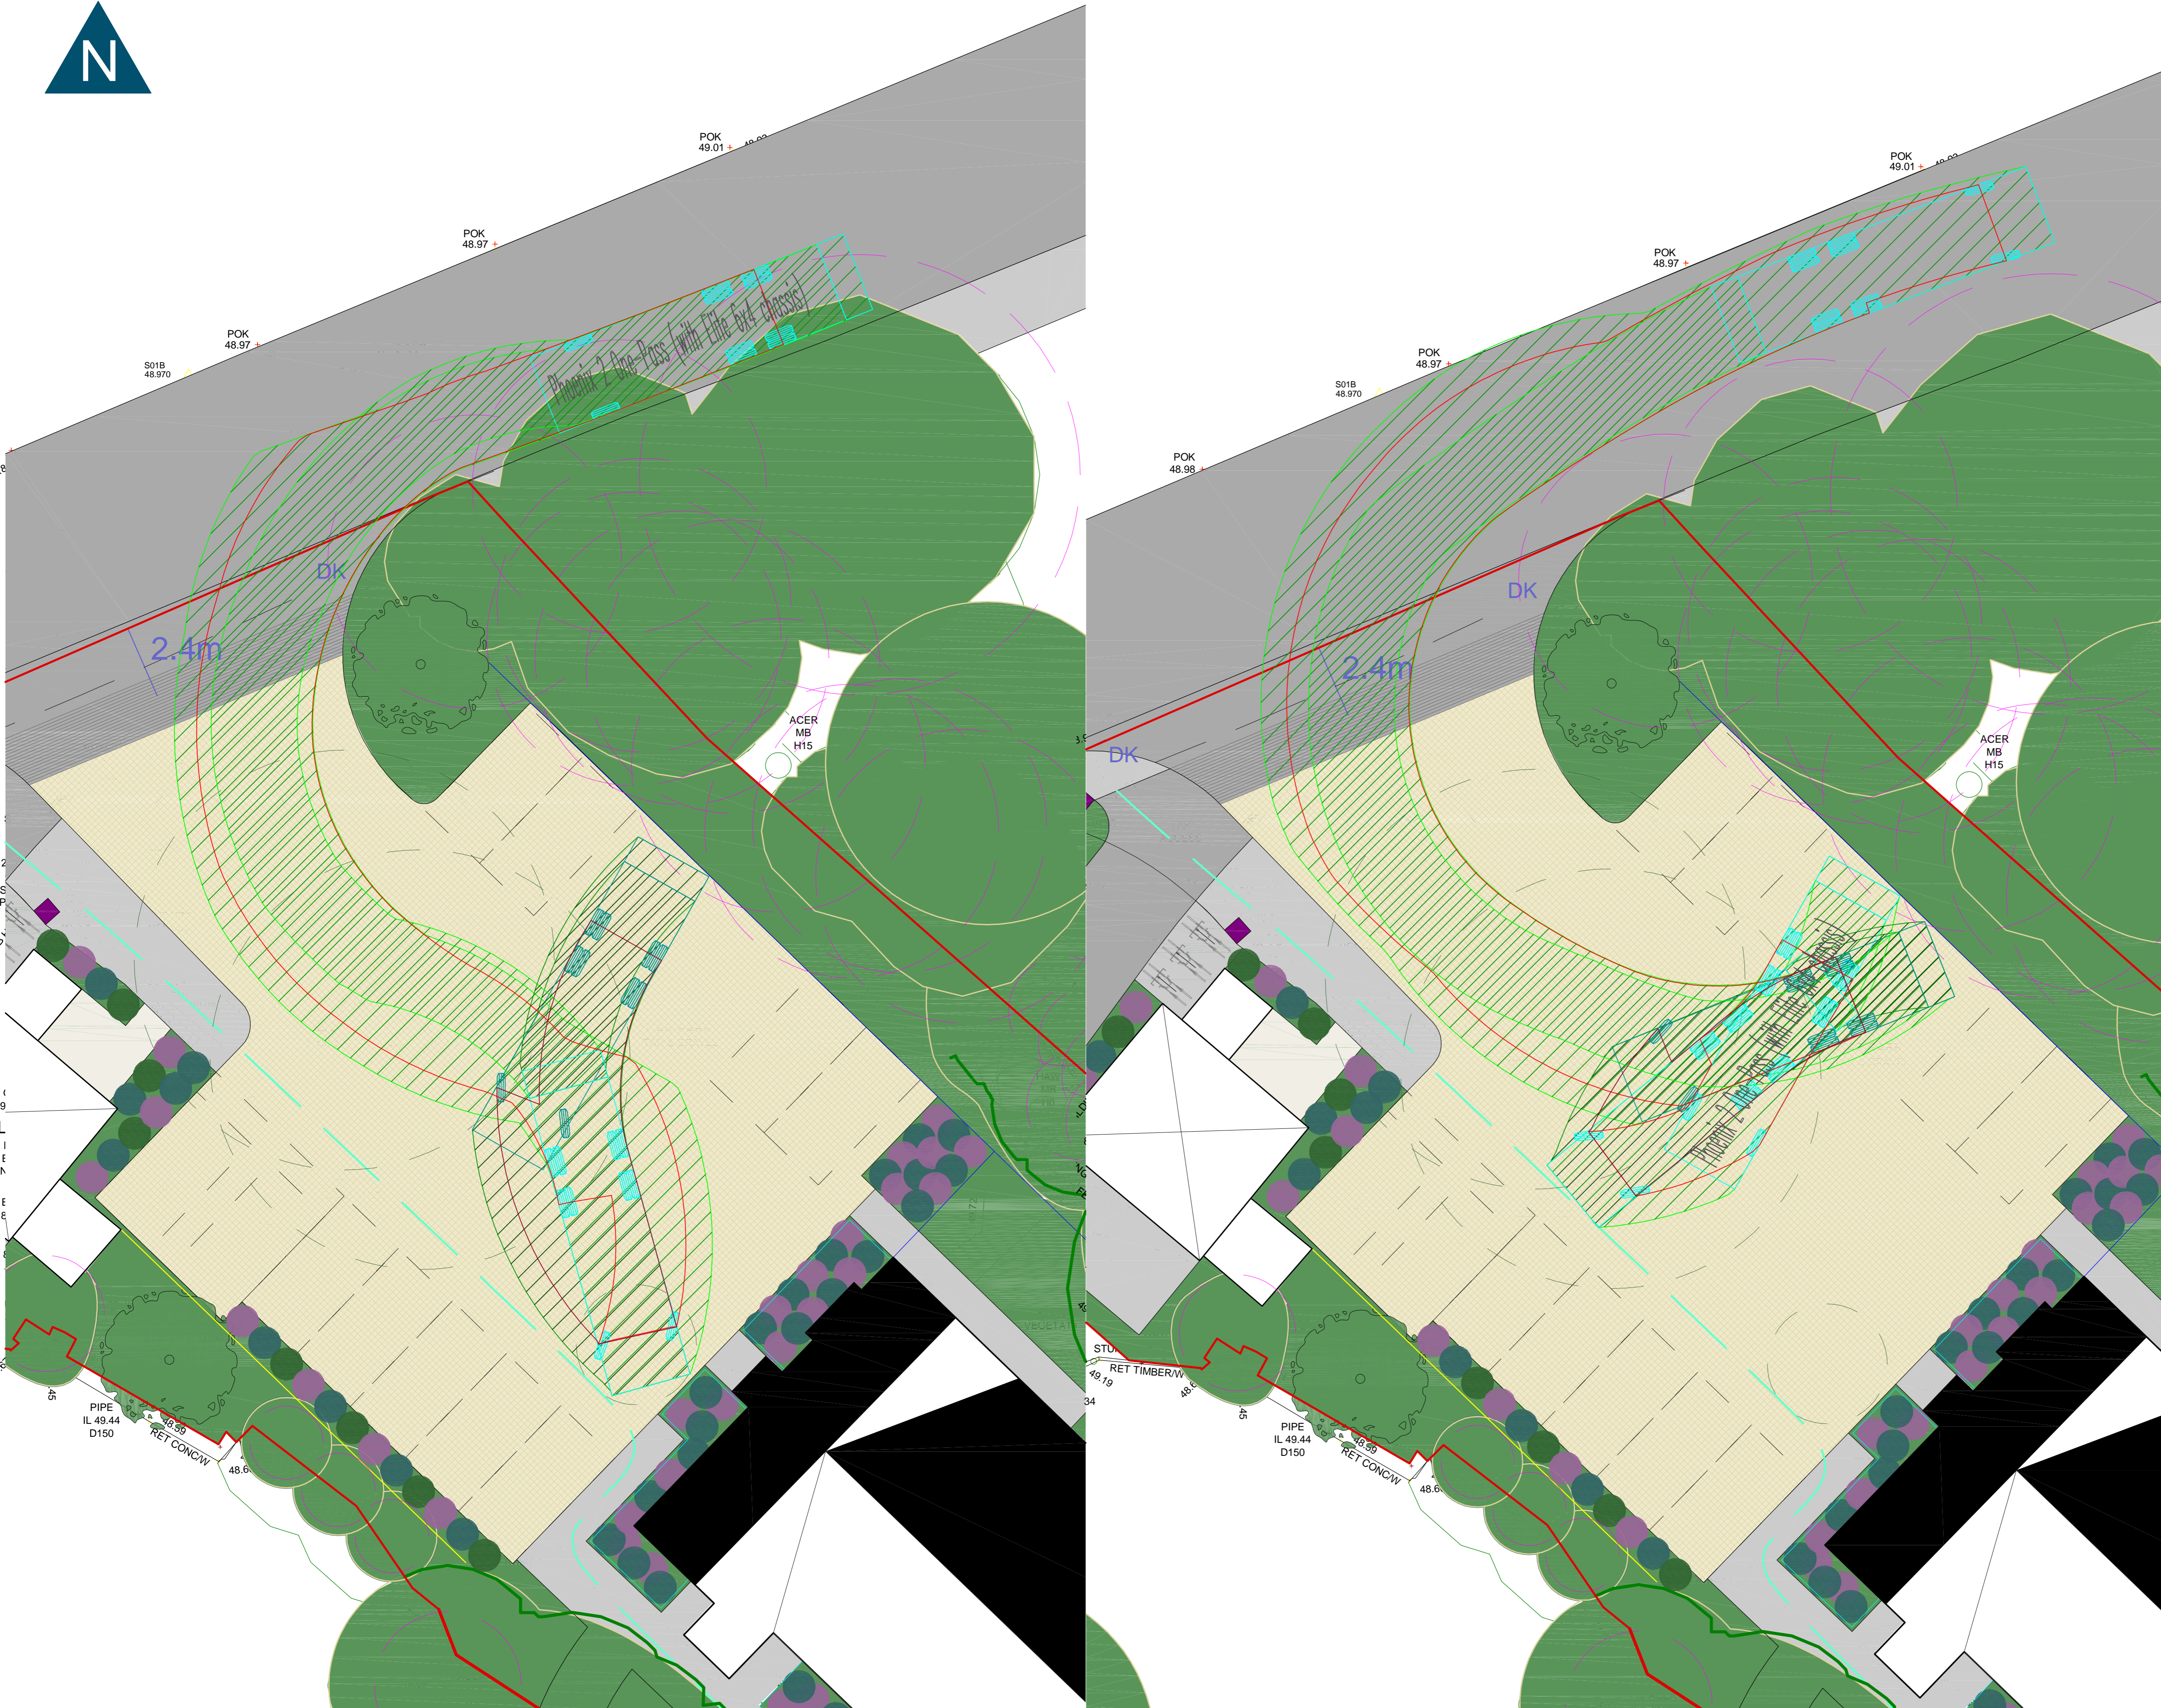
19156.TPO.107.09

| Phoenix 2 One-Pass (with Elite 6x4 chassis) | 11.000m |
| Overall Length | 2.650m |
| Overall Width | 3.777m |
| Overall Body Height | 0.330m |
| Min Body Ground Clearance | 2.650m |
| Track Width | 4.00s |
| Lock to Lock Time | 11.500m |
| Kerb to Kerb Turning Radius | |

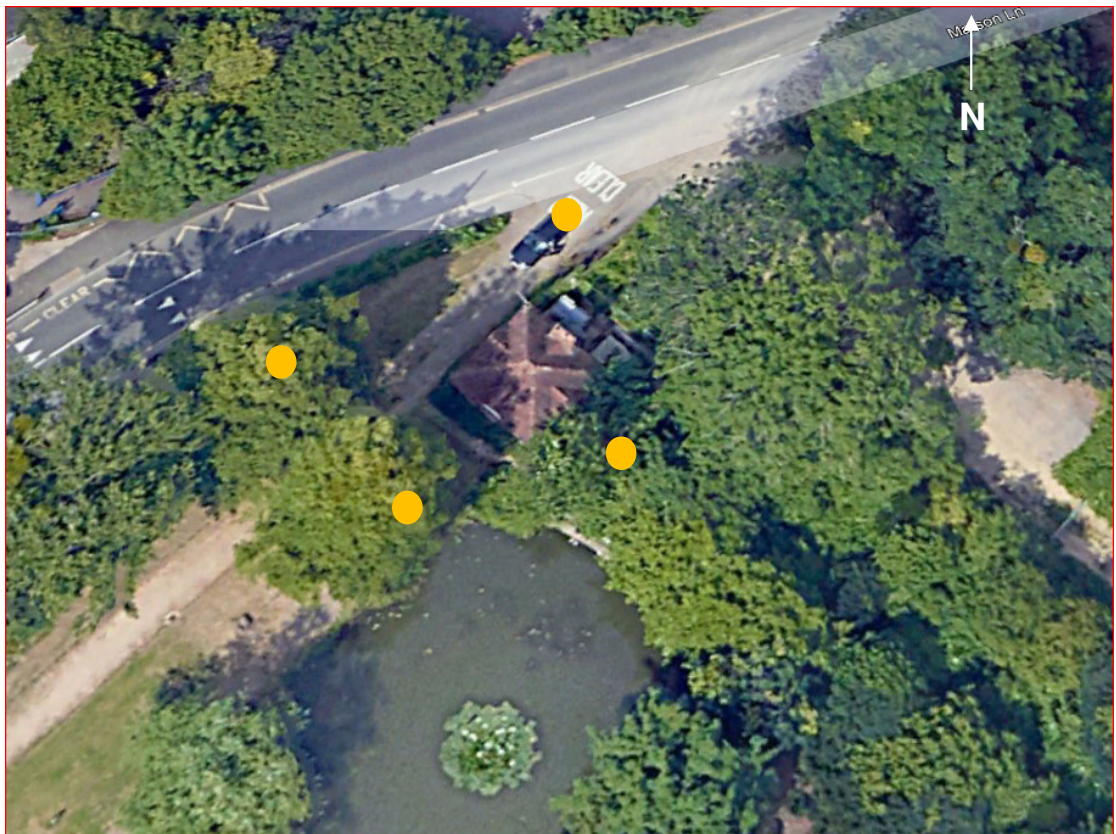
- 3.21 The positions of the surveyors around the building during the survey are illustrated in Figure 1 below.

Figure 1. Surveyor locations for roost survey conducted.

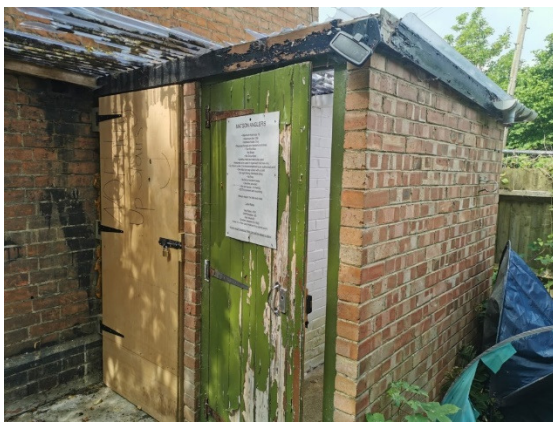
Photograph 3. View of the toilet block extension.

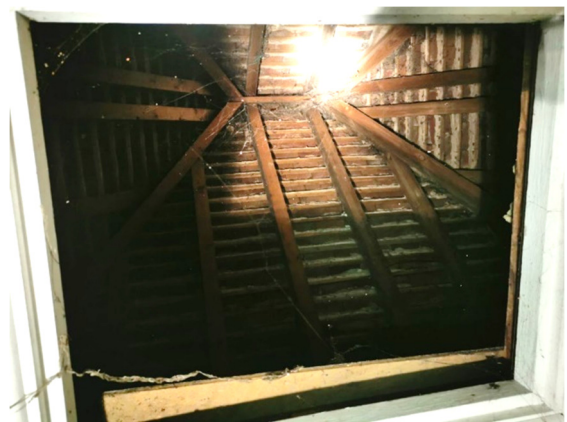
Photograph 4. View of loft space structure with no lining.

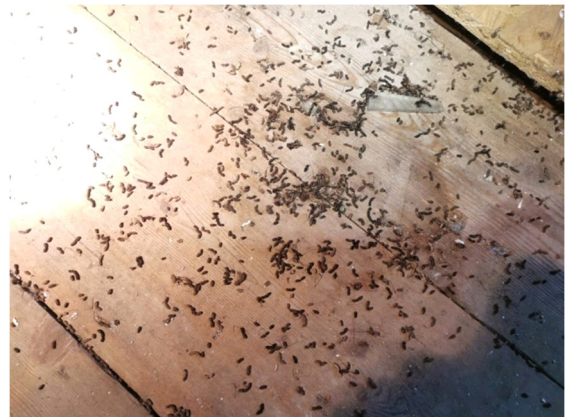
Photograph 6. Cluster of lesser horseshoes dropping in rear upstairs room.

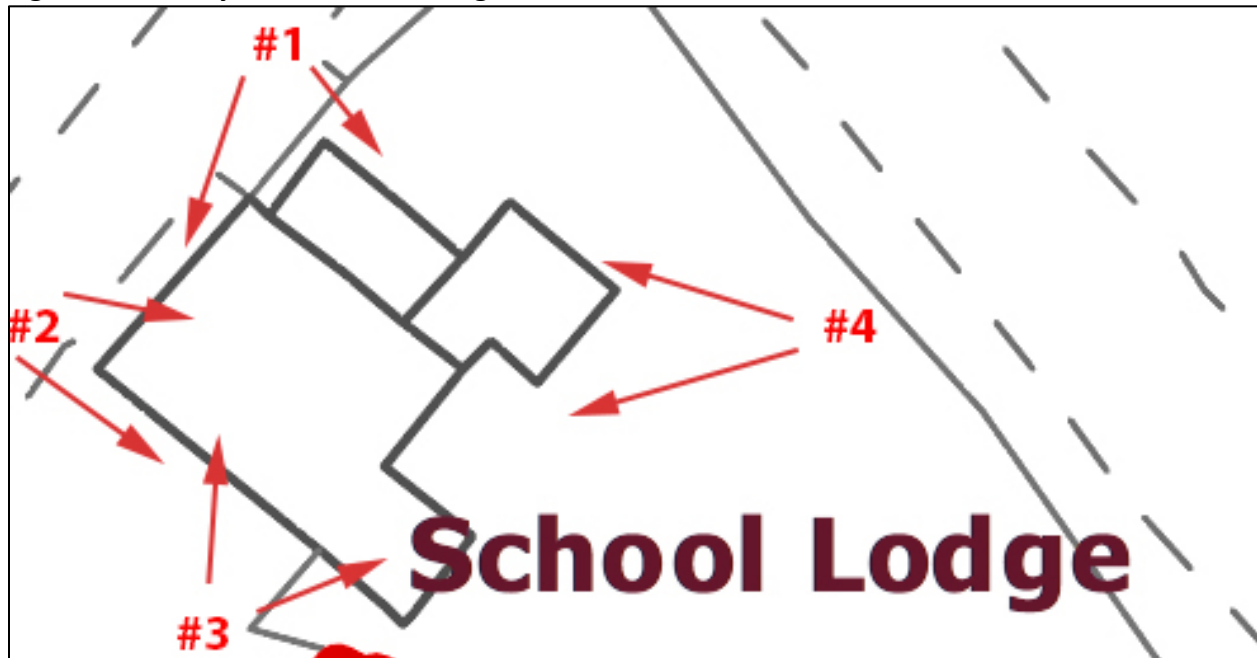
Figure 2 – Surveyor locations and sight lines.

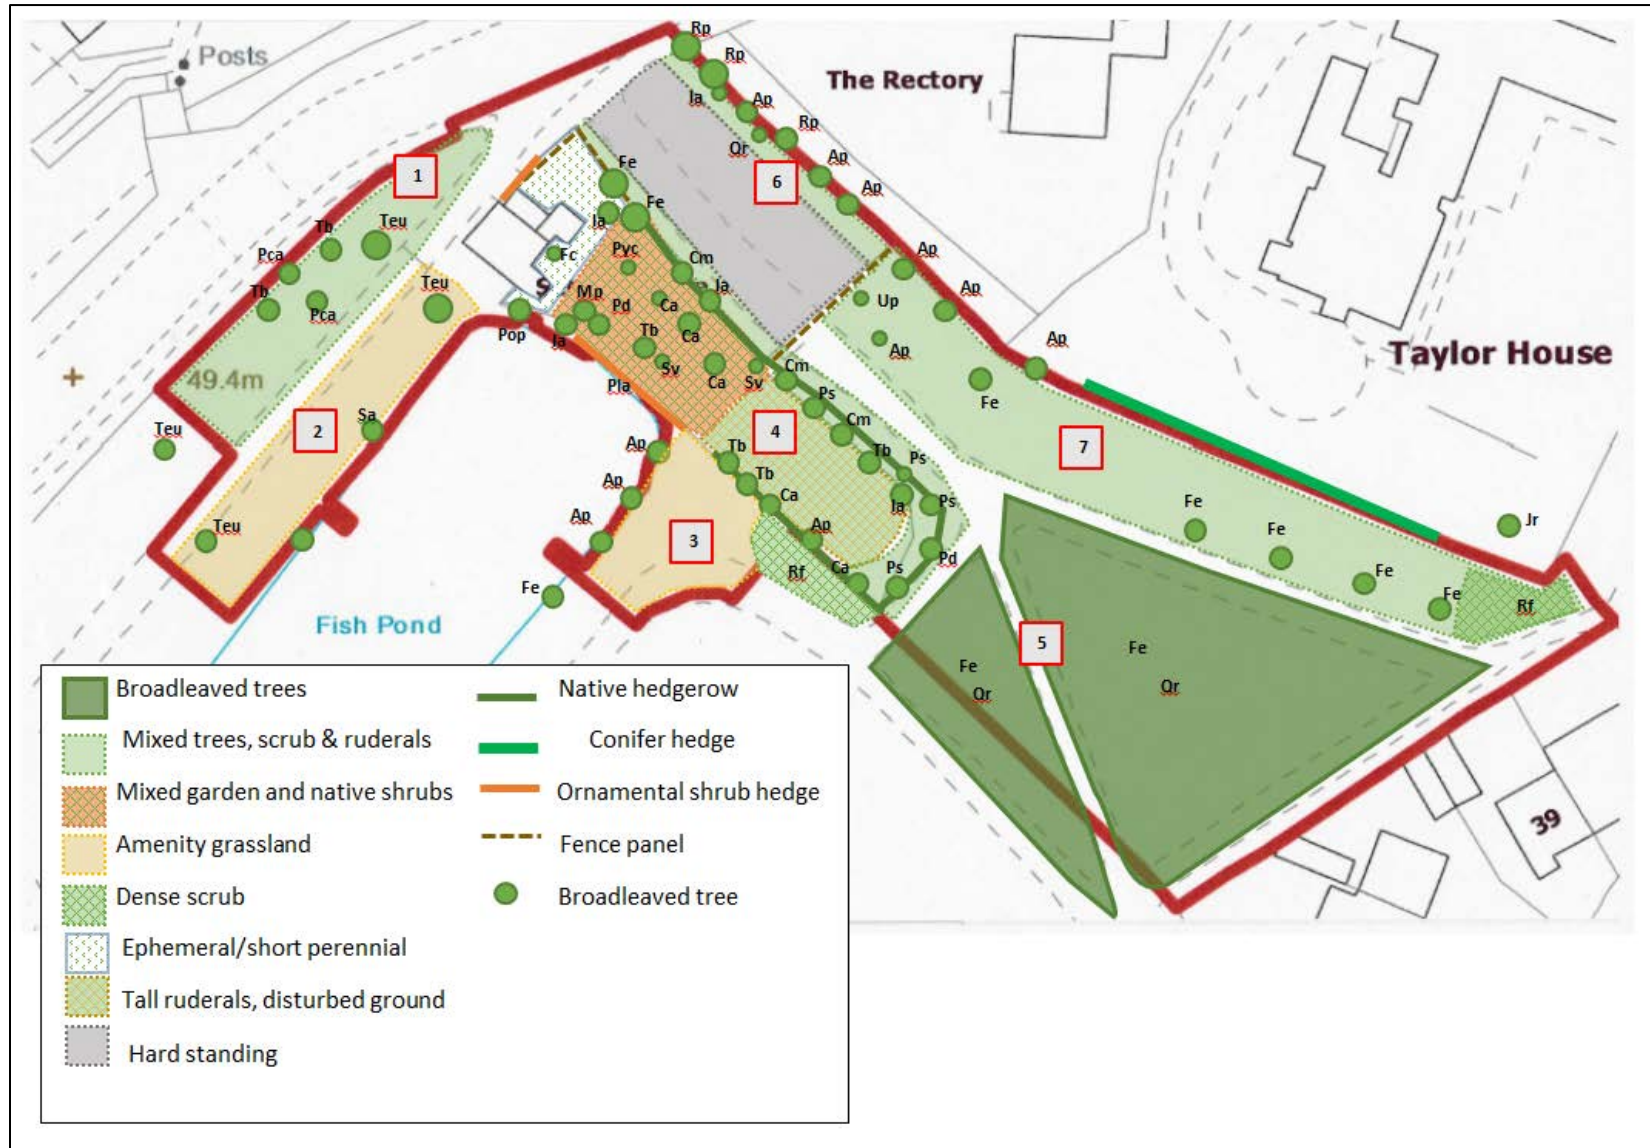
Figure 3. Phase 1 Habitat Map

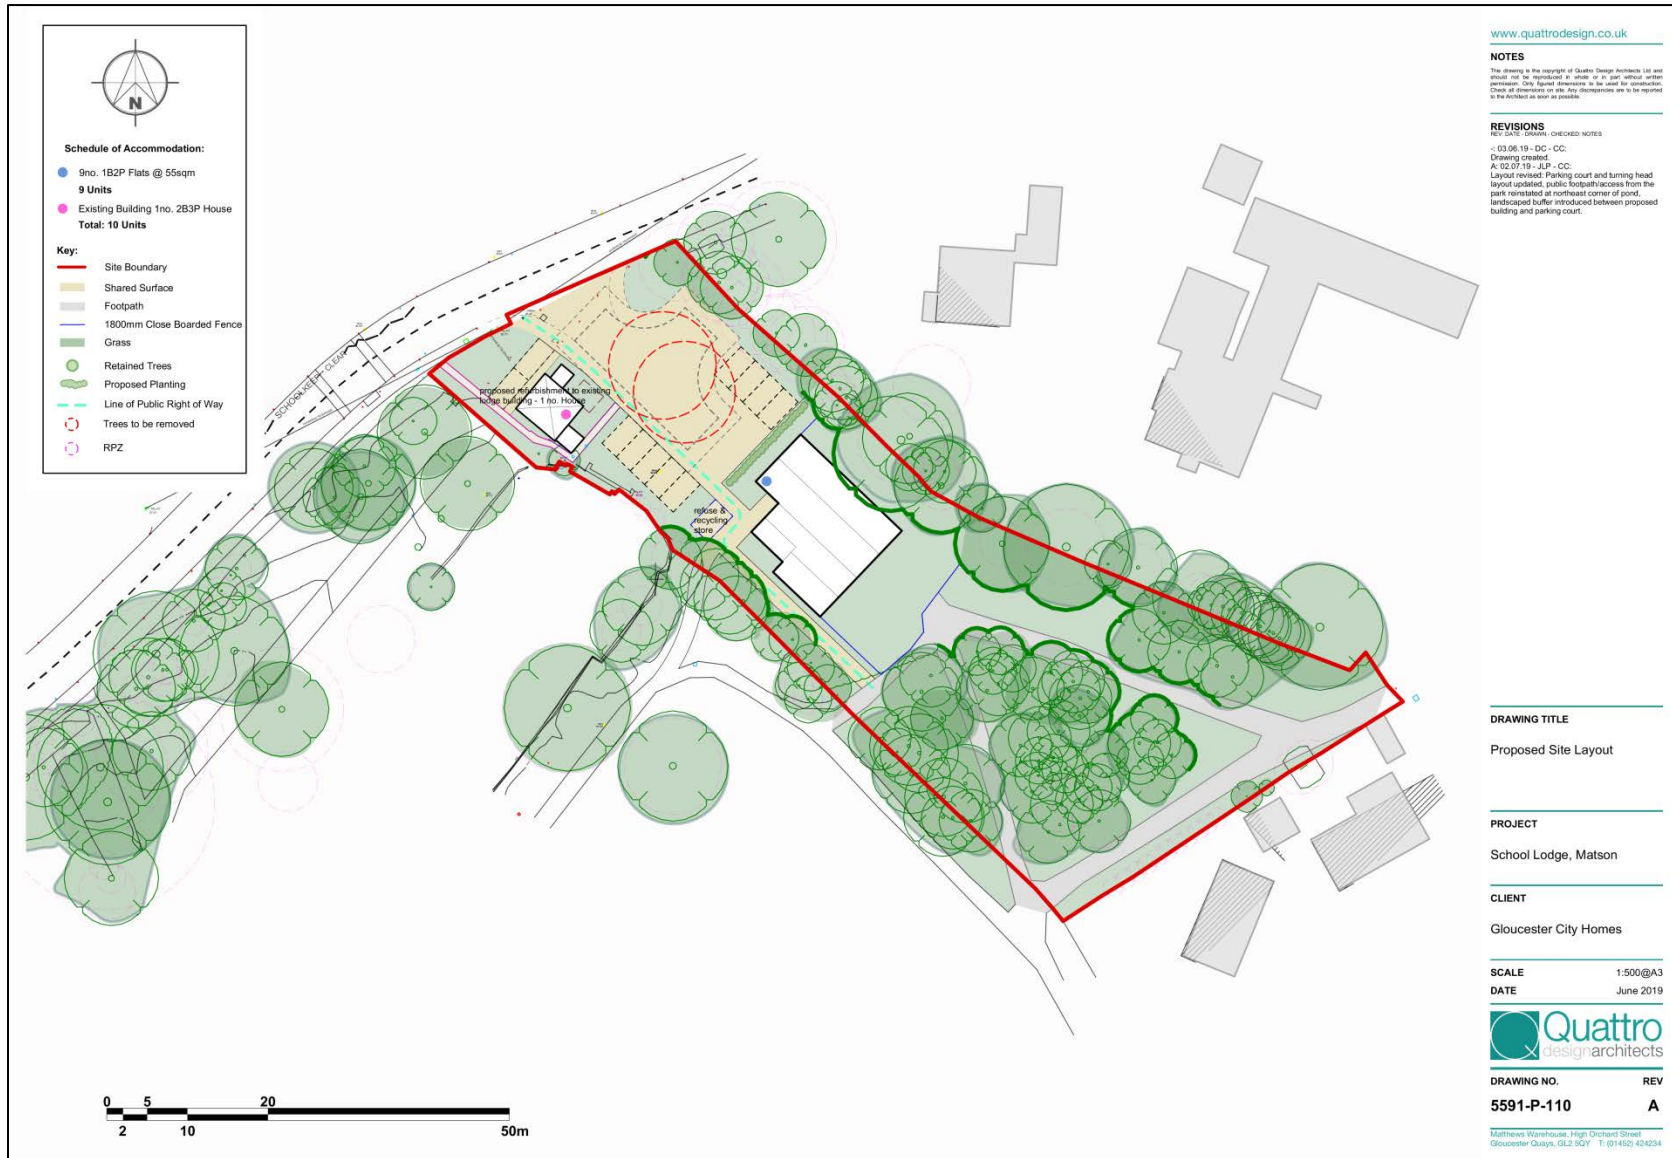
Figure 4. Current scheme proposal including red line boundary.

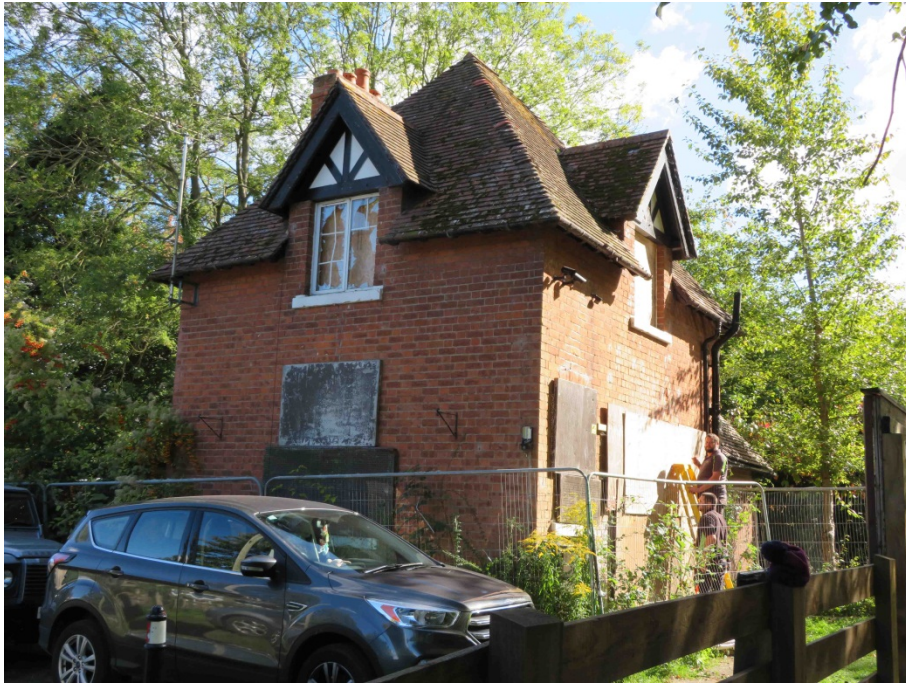
Plate 15 – Potential bat access points into lodge.

The lodge was built of brick, beneath a hipped, tiled roof (e.g. Plates 2, 13 & 14). It had been empty for some time and had been subjected to vandalism. There were numerous potential bat access points present, mostly resulting from damage to the roof (e.g. Plate 15). There were also some potential bat roosting features present, including gaps behind flashings (e.g. Plate 16) and holes in walls (e.g. Plate 17).

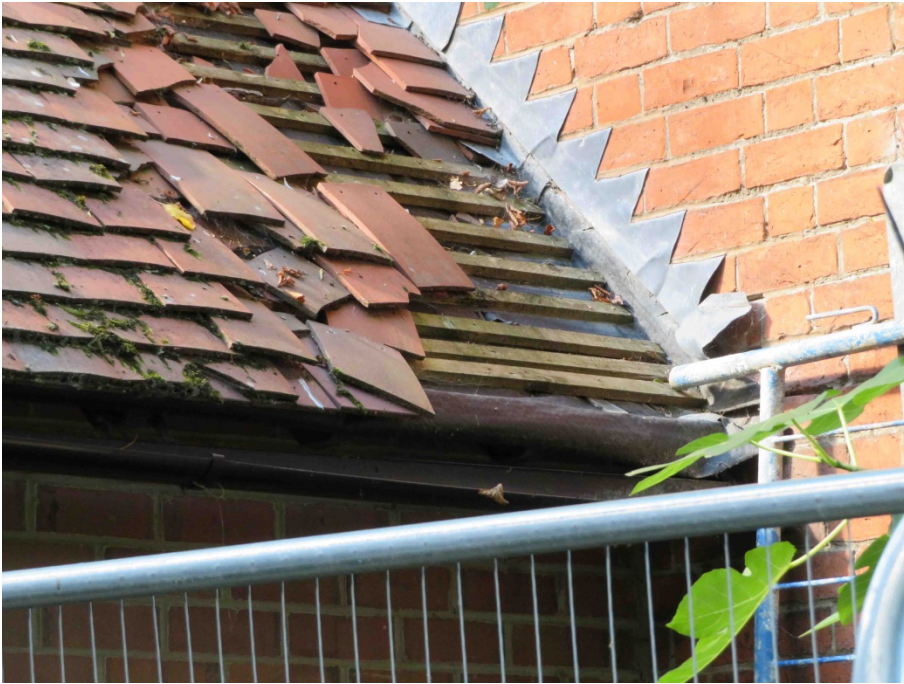
Plate 16 – Potential bat access points into lodge.

- 4.6 A single building (the Lodge) is present in the north of the Site which was inspected both externally and internally. The external inspection found the Lodge to be mainly square two-story building, of brick construction with a hipped roof, clay roof tiles and dormer windows present on three aspects and a chimney stack on the eastern aspect. The Lodge is not in current use and had fallen into a state of disrepair and had been boarded up to stop vandalism. A large number of missing and slipped

roof tiles were noted, lead flashing was raised and missing providing access gaps for bats and there were holes in the brick walls and missing mortar.

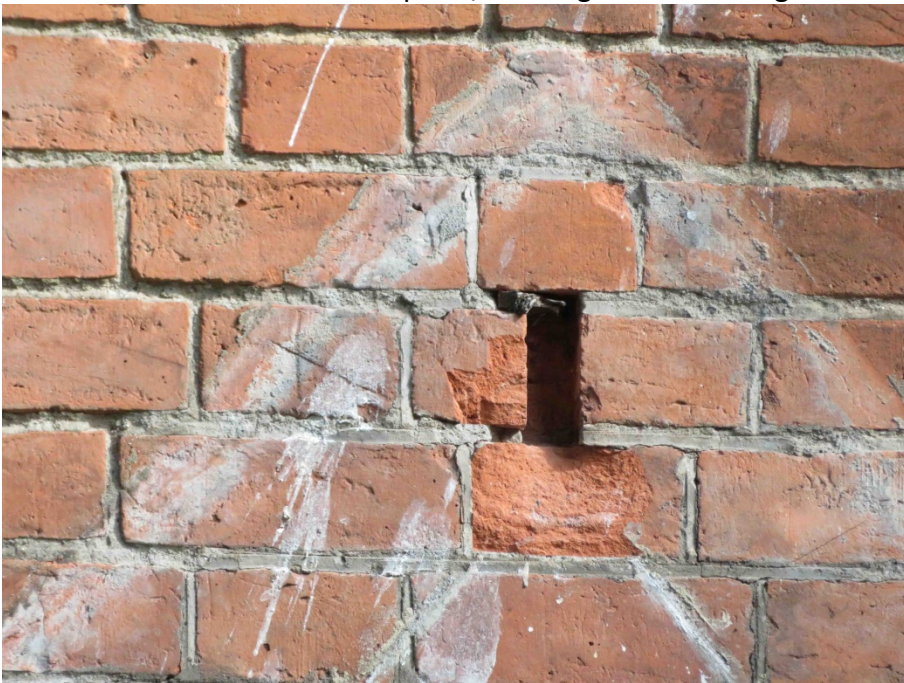
Plate 17 – Potential bat access point/roosting feature in lodge wall.

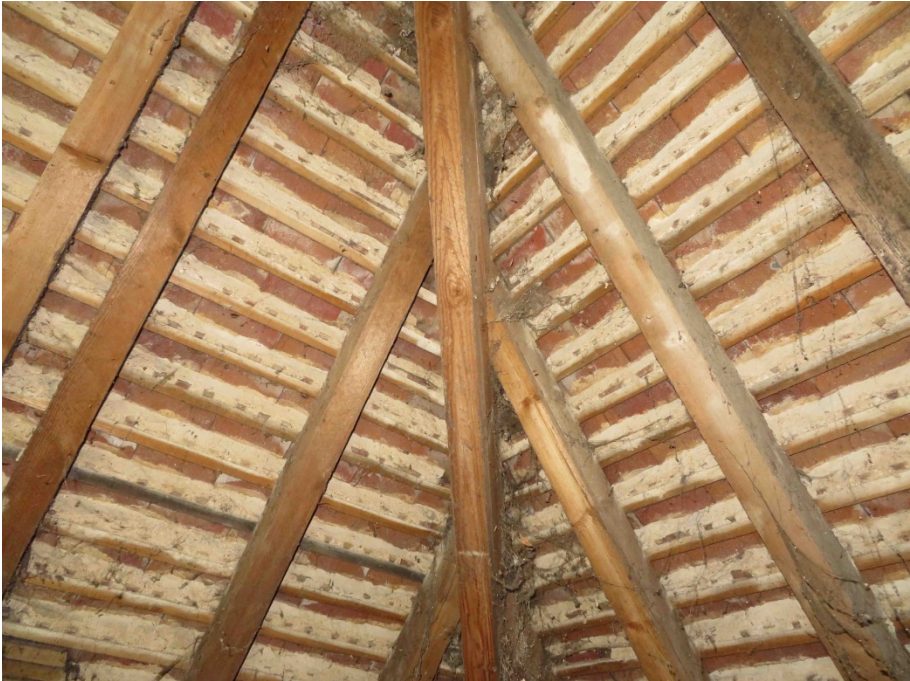
Plate 20 - Bat (red) and bird (black) access points into lodge.

During the course of the first bat activity, a single Common Pipistrelle was seen to emerge from the location indicated with a black arrow in Plate 20 and a Great Tit was seen accessing the building at the location indicated by a red arrow, on the same plate. This was the only occasion when bats or birds were seen to be using the building.

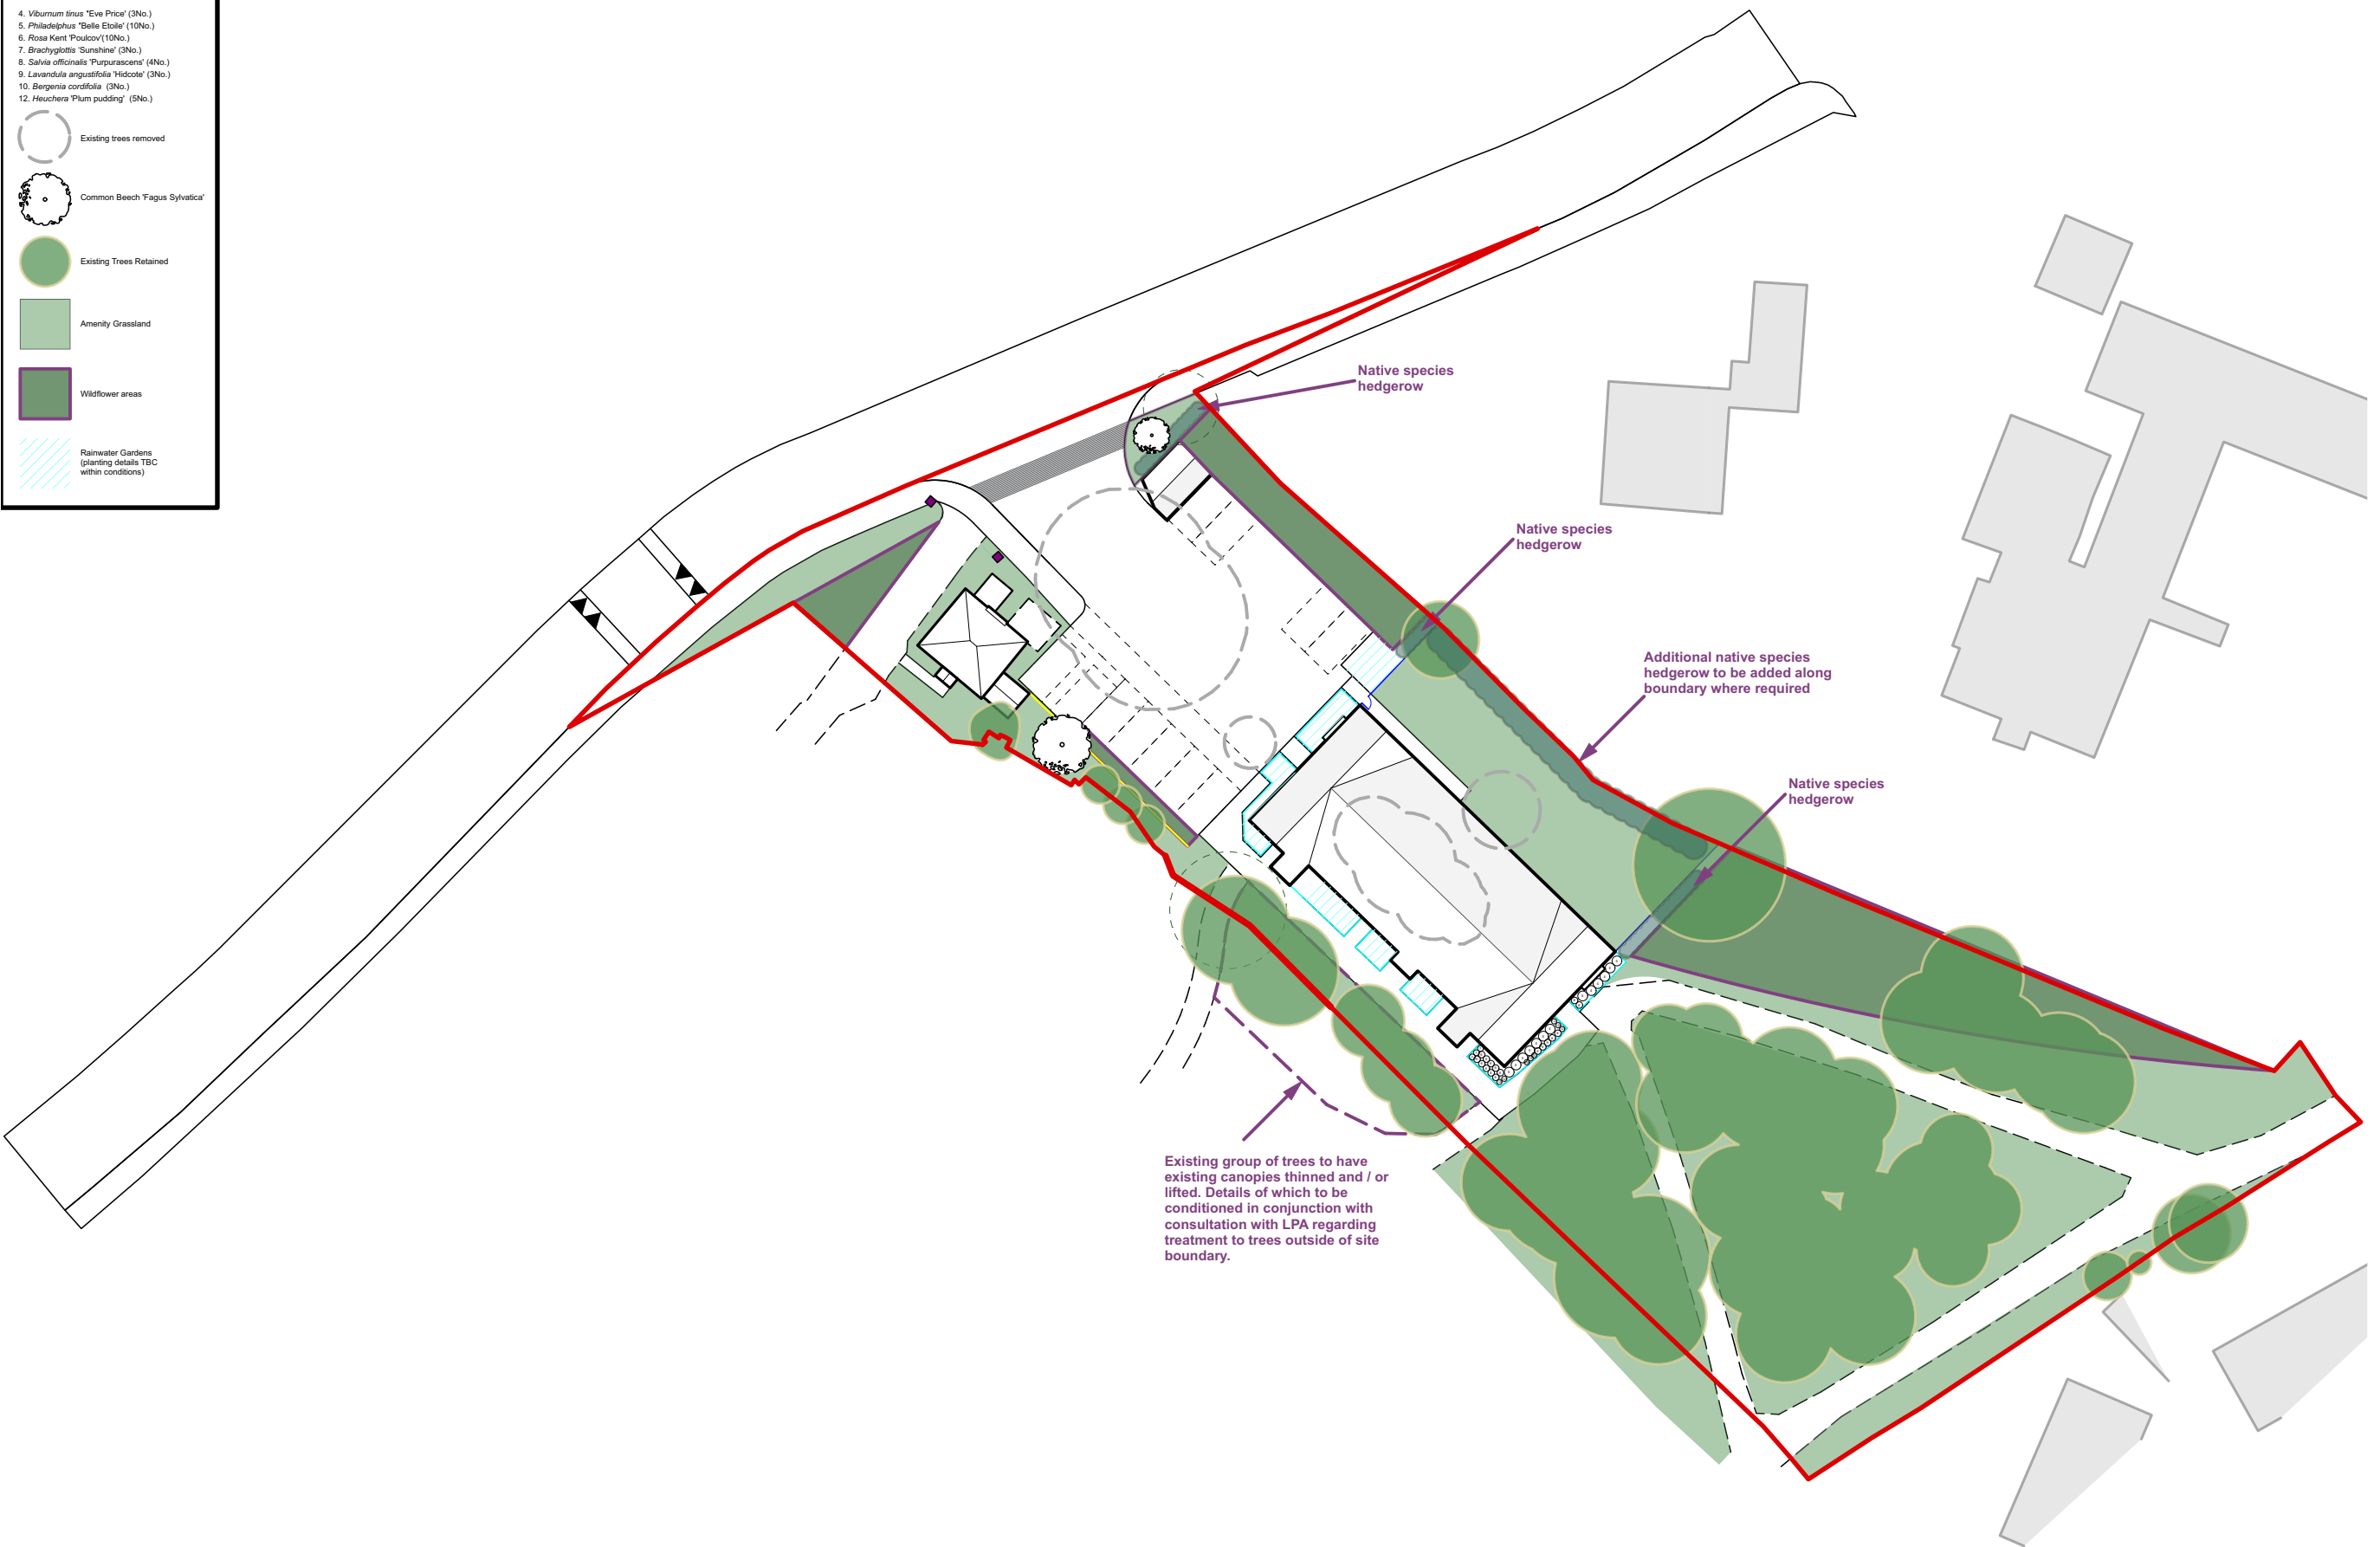
Soft Landscaping Plan

- 4. Viburnum tinus 'Eve Price' (3No.)
- 5. Philadelphus 'Belle Etoile' (10No.)
- 6. Rosa Kent 'Poucov'(10No.)
- 7. Brachyglottis 'Sunshine' (3No.)
- 8. Salvia officinalis 'Purpurascens' (4No.)
- 9. Lavandula angustifolia 'Hidcote' (2No.)
- 10. Bergenia cordifolia (2No.)
- 12. Heuchera 'Plum pudding' (5No.)

- Existing trees removed
- Common Beech 'Fagus Sylvatica'
- Existing Trees Retained
- Amenity Grassland
- Wildflower areas
- Rainwater Gardens (planting details TBC within conditions)

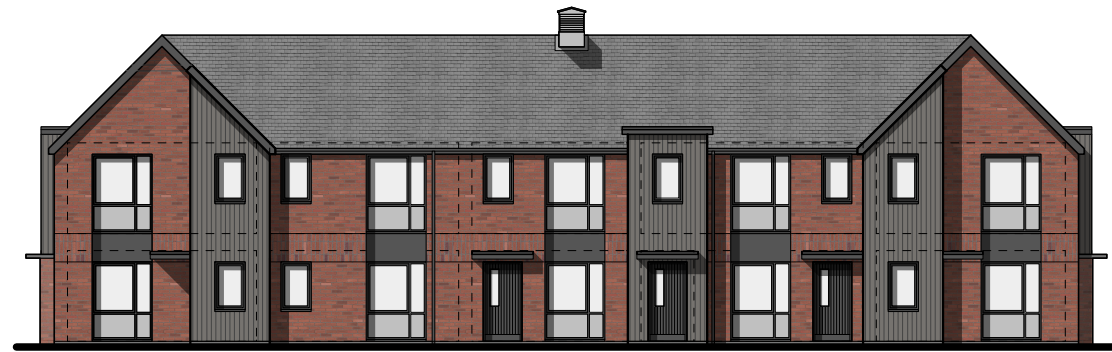
Plot 5
Plot 1
South West Elevation

- Key**
- Red brick - Running bond
 - Red brick - Soldier stack course
 - Grey roof tile
 - Grey standing seam
 - Dark grey window and door frames
 - Obscured glazing to lower sections of full height windows
 - Dark grey RWGs

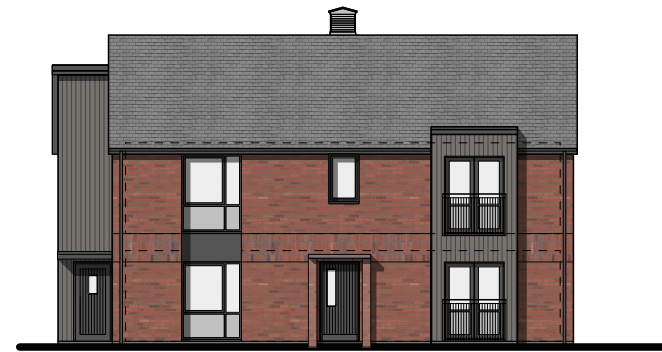
Plot 9
Plot 4
South East Elevation

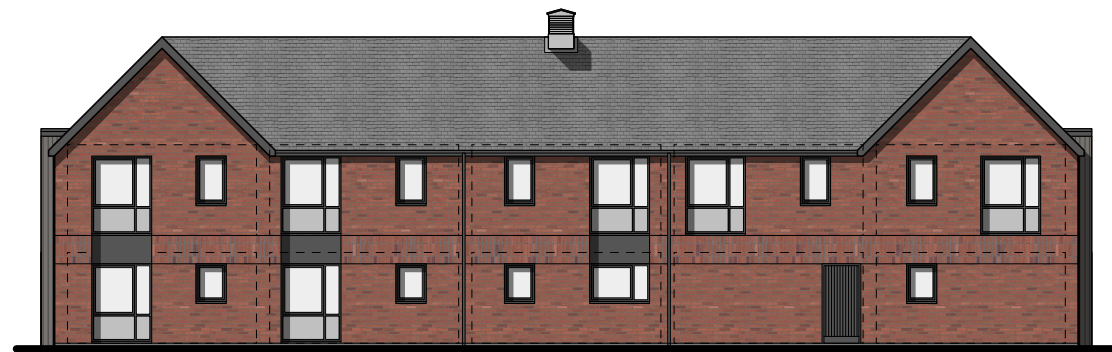
Plot 9
Plot 4
North East Elevation

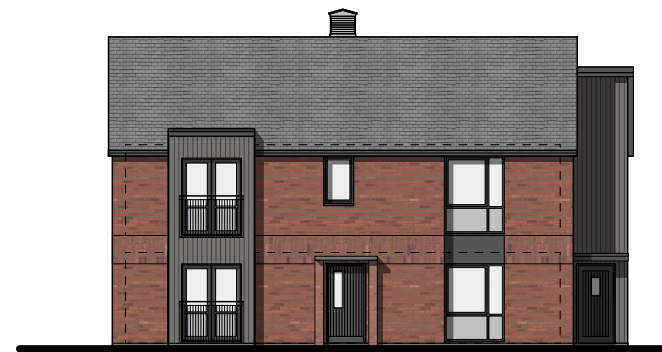
Plot 5
Plot 1
North West Elevation

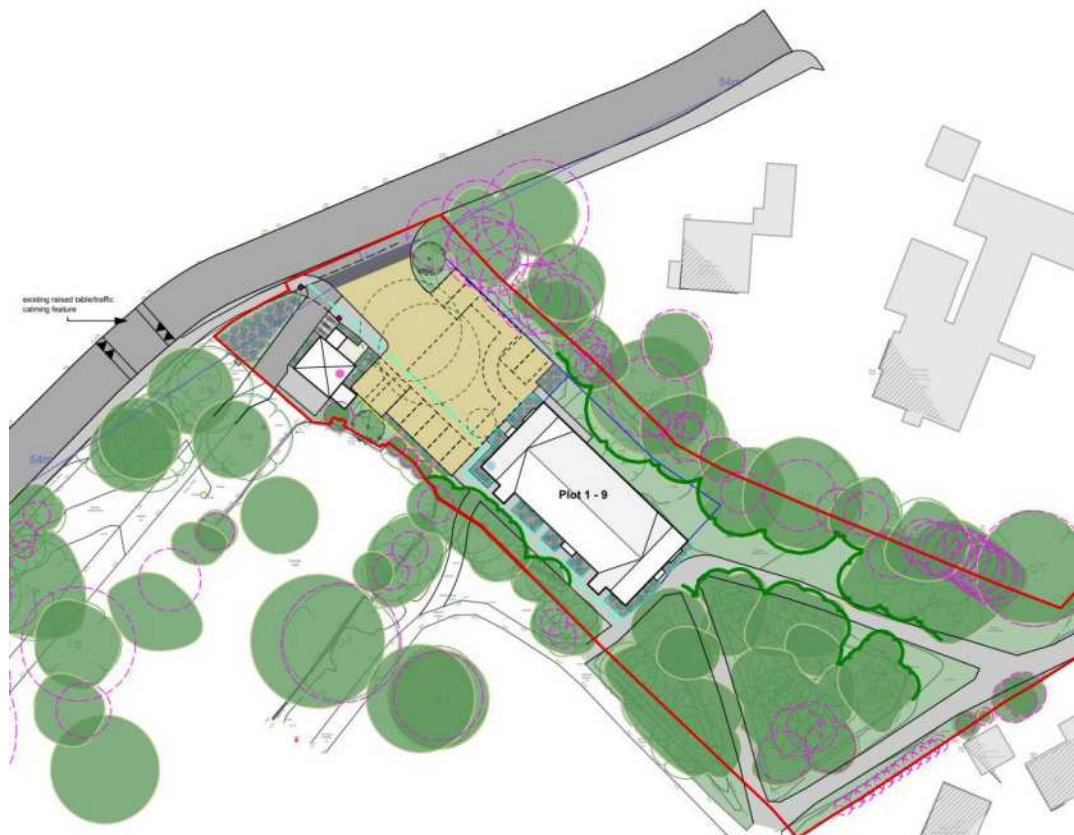
Figure 4.0 – Proposed Site Layout

- 4.2 A new vehicular access will be created from Matson Lane to the northwest. The proposed development plan is included in [Appendix A](#).
- 4.3 As part of the residential development proposals a new parking area, refuse & recycling store and infrastructure enabling works will be carried out.

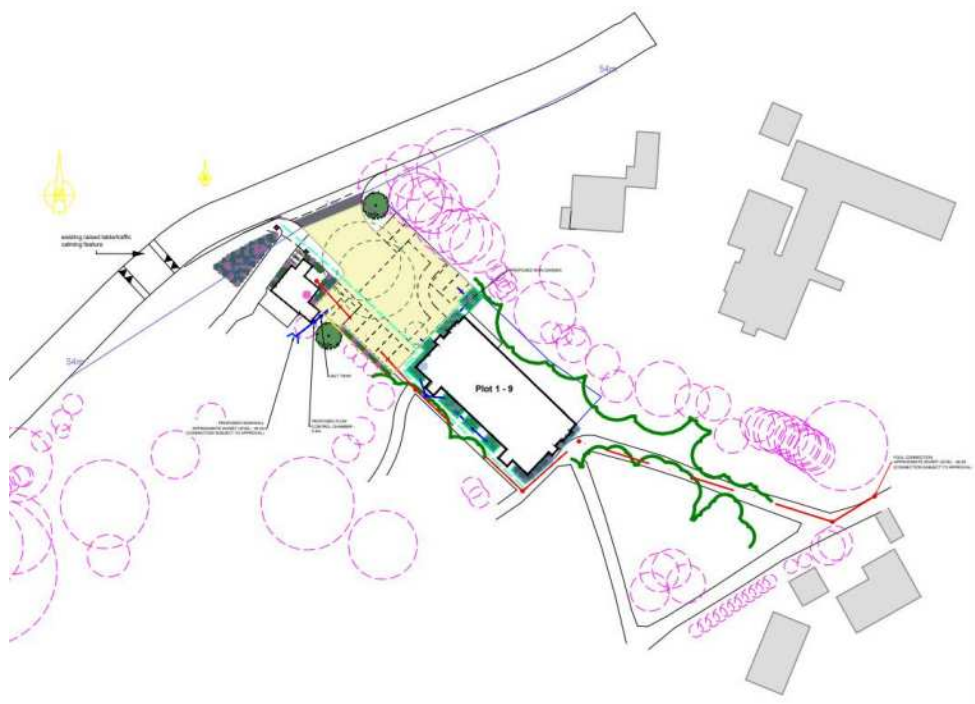
Figure 5.0 – Indicative Drainage Strategy

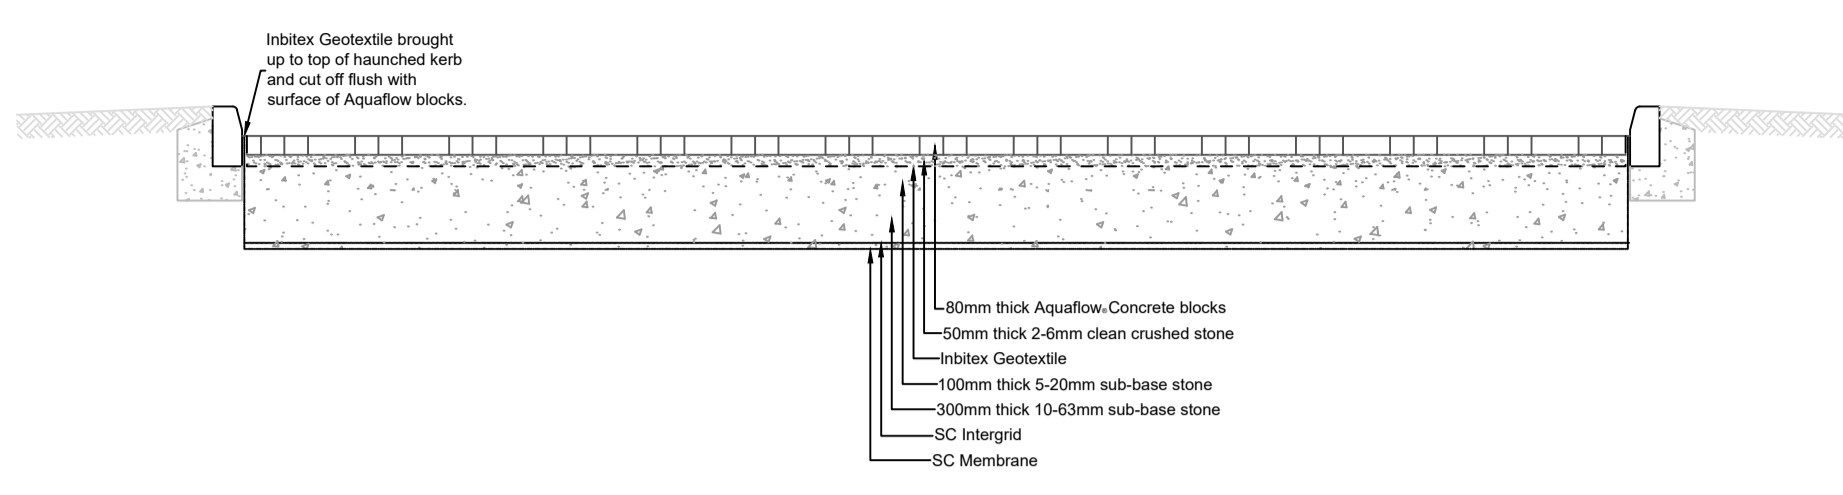
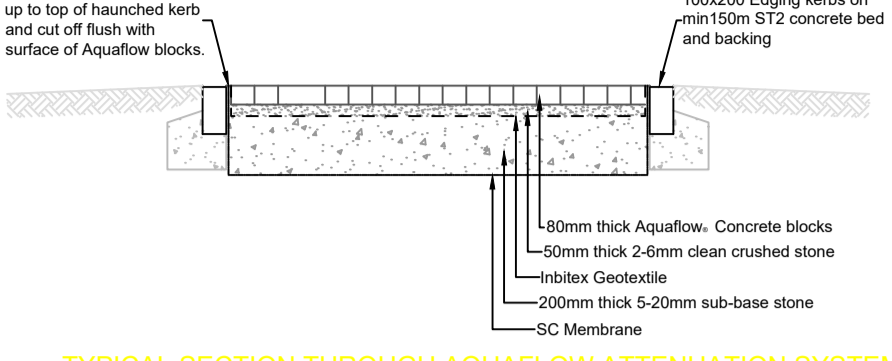
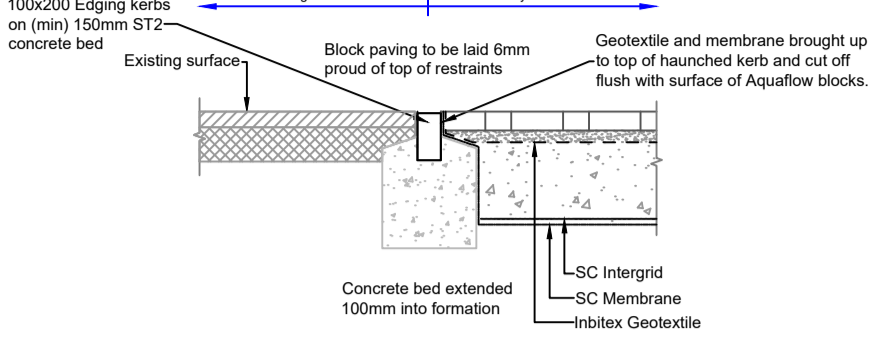
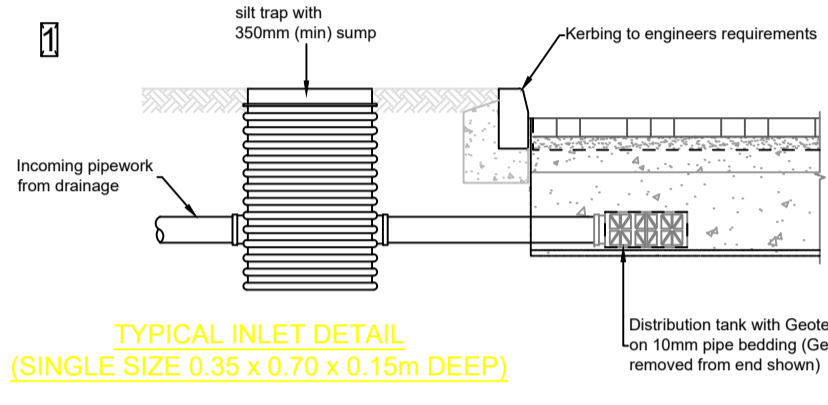
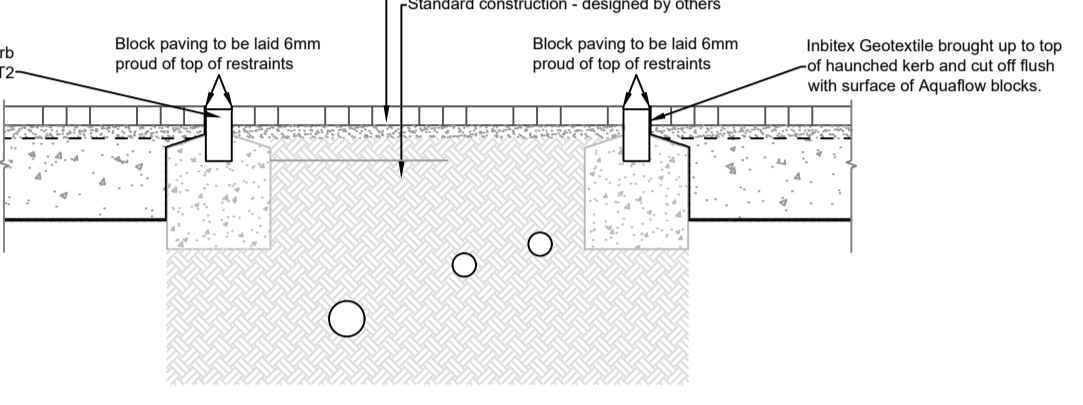
ROAD LEVEL RAISED TO 50.50 AOD MINIMUM TO PROTECT DRAINAGE
