School Lodge, Matson

Swept path analysis of an 11m refuse vehicle

Update Ecological Appraisal

School Lodge, Matson, November 2022

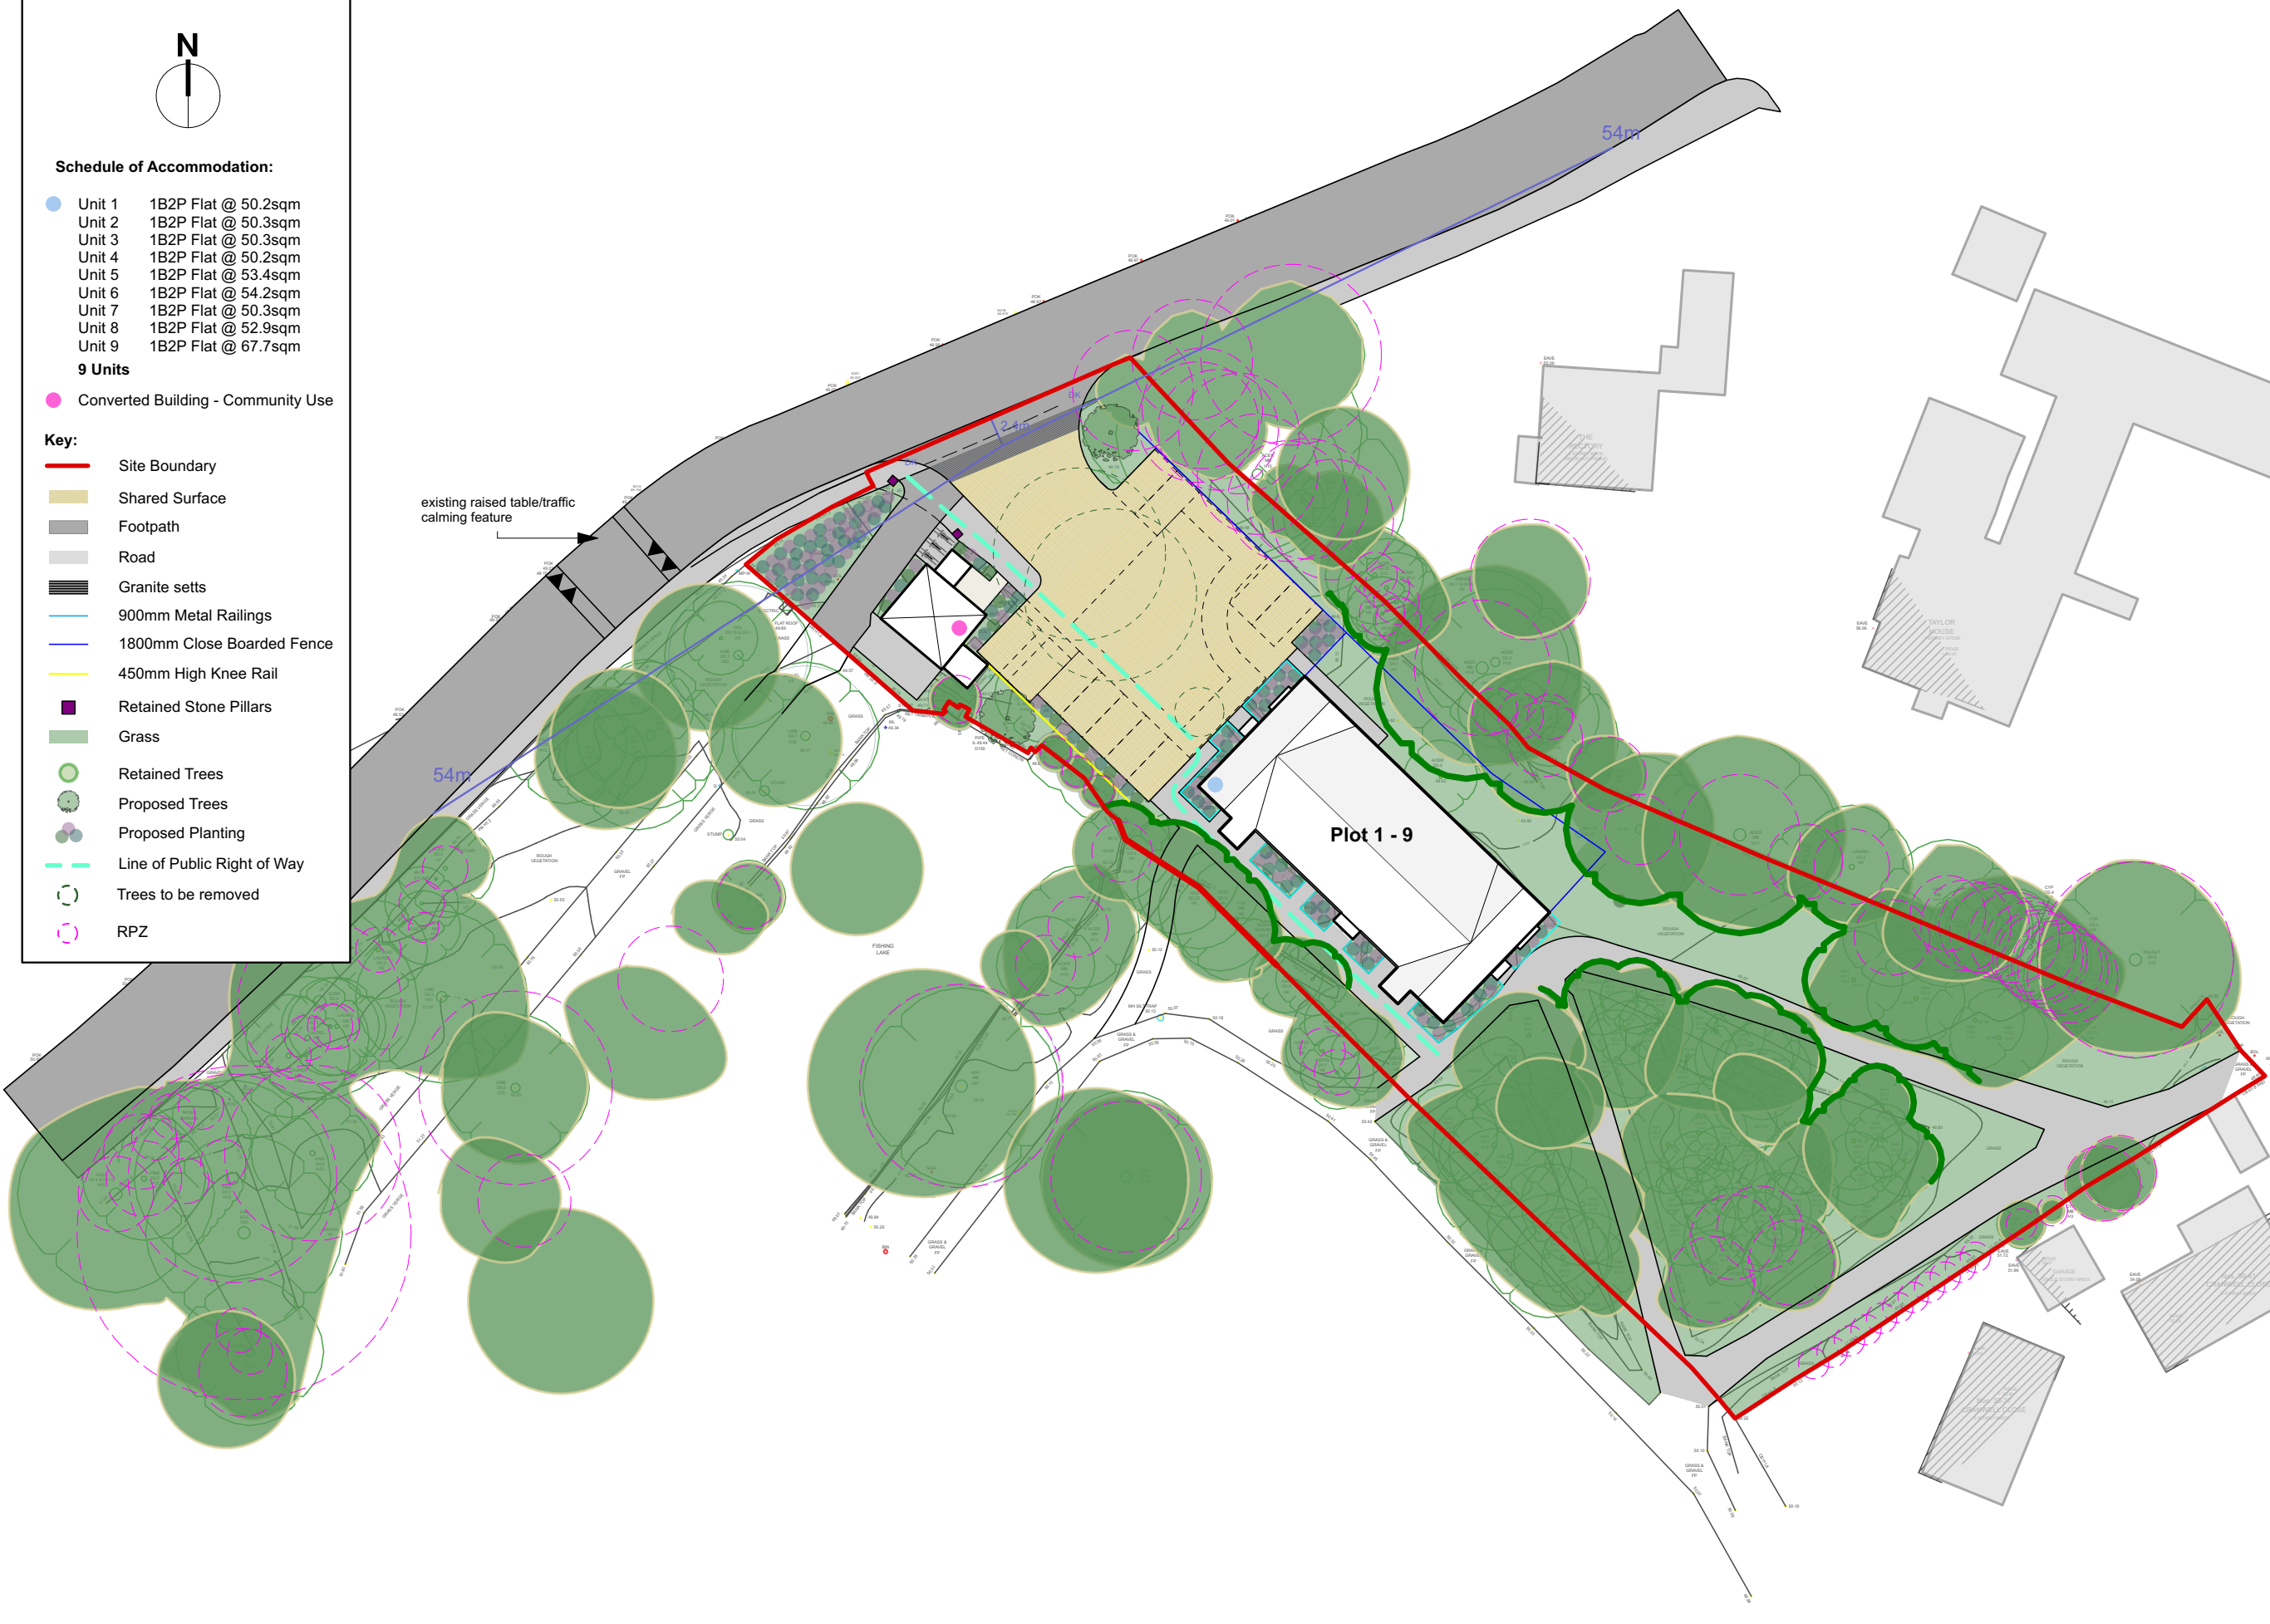
Proposed Site Layout

- Site Boundary
- Shared Surface
- Footpath
- Road
- Granite setts
- 900mm Metal Railings
- 1800mm Close Boarded Fence
- 450mm High Knee Rail
- Retained Stone Pillars
- Grass
- Retained Trees
- Proposed Trees
- Proposed Planting
- Line of Public Right of Way
- Trees to be removed
- RPZ

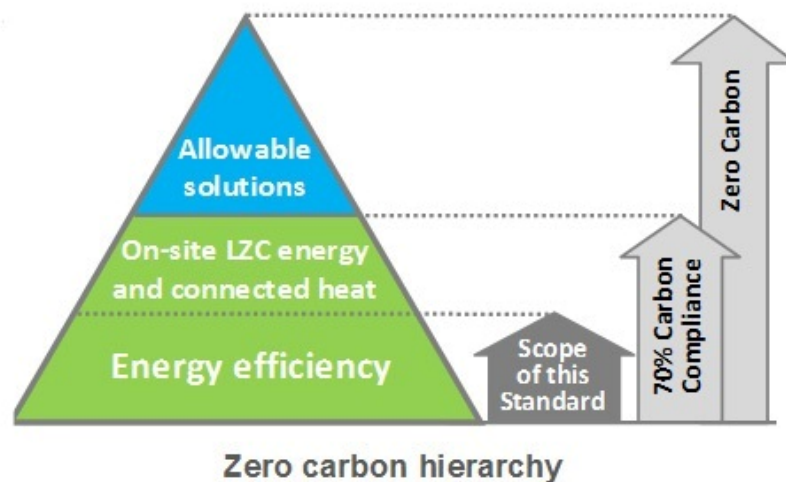
Figure 2

- 3.2.1. In order to improve the dwelling performance to achieve AD-L 2021, various upgrades have been made to almost all physical elements of a typical AD-L 2013 specification.
- 3.2.2. The proposed development adopts the good design principles endorsed and promoted by The Zero Carbon Hub, the construction industries' key advisors and partners with the Governments Communities and Local Government Department. This guidance follows the general good principles of energy efficiency as the industry moves towards zero carbon. The principles are illustrated in figure 2 below.

- 3.2.3. To reduce the residual carbon emissions, a number of improvements were made to the standard material and product specification. These improvements include:
- *Improved insulation levels*
 - *Upgraded heating and hot water controls*
 - *Design air permeability of 5.01m³/hr/m²*
 - *Bespoke, low heat loss thermal bridging designs*

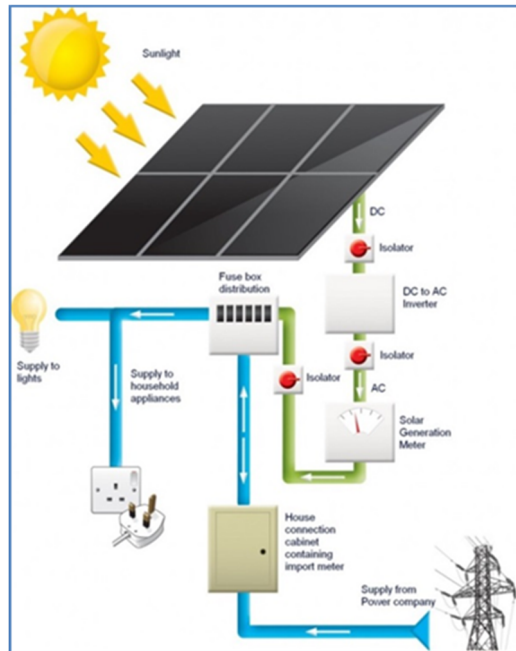
The PV system typically produces direct current (DC) which is then sent through an inverter to supply the house with electricity. If a greater amount of electricity is produced than used by the household, this extra can be exported to the national grid.

A PV cell is assessed on its peak power rating. This is tested by exposing the cell to the equivalent of full solar radiation and measuring the power output. The peak power is input into the Design SAP software as well as the physical attributes of the installation such as pitch, orientation and over-shading. A total energy saving per year can then be calculated through SAP for the PV installation. This is then offset against the electricity energy demand for the house.

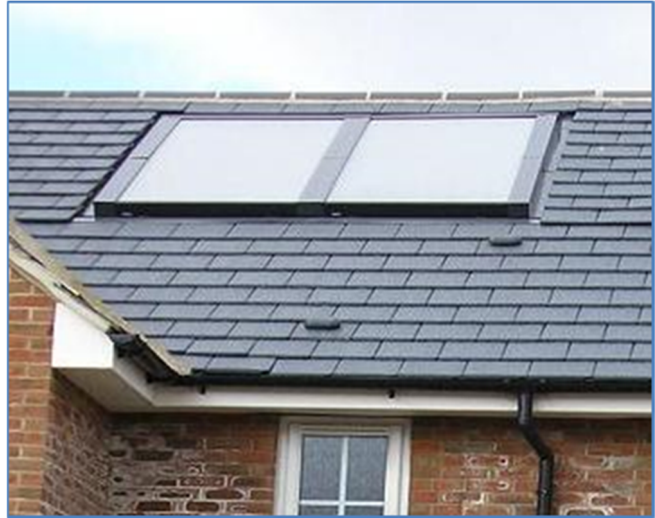
SHW systems generate energy which is used to heat stored water (in a special solar hot water cylinder) which offsets the energy required for the boiler, thereby reducing fuel use and reducing carbon emissions. Therefore, SHW systems are ideally utilised when the design of a dwelling already calls for a hot water cylinder, and not when a combination boiler is specified.

There are two main SHW systems: evacuated tubes and flat plate collectors.

Evacuated tubes are more efficient at transferring solar irradiation to the fluid although flat plate collectors are considered to be better aesthetically and to install.

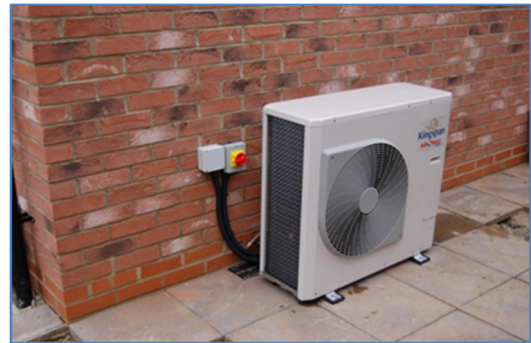
ASHP provide heating and hot water to a home through thermal energy gathered from air outside the dwelling. Systems can be designed to work in conjunction with a boiler system but in the case of energy efficient new builds it is possible for an ASHP unit to provide 100% of the heating and hot water demand.

The thermal performance of the unit depends on the outside temperature as well as the unit's Coefficient of Performance. This is the ratio of thermal energy produced to energy used. A typical value for this would be around 3.5, meaning that for every 1kW of electricity consumed the unit would provide 3.5kW of thermal energy to the household. This efficiency leads to large carbon and energy savings for both space and water heating.

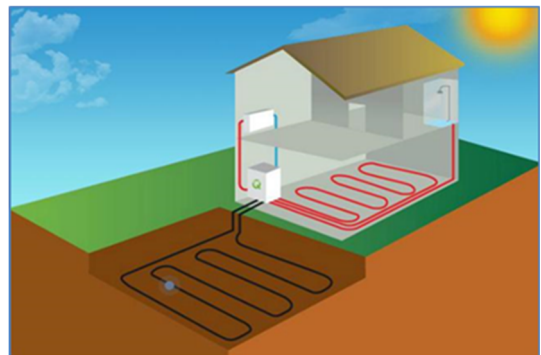
GSHP provide heating and hot water to a dwelling through geothermal effects. A GSHP system would offset the energy demand from the main space heating. There is, however, an additional electricity demand for the pump and control system. This would reduce energy savings from the installation.

GSHP are expensive to install and rely on having appropriate ground conditions and suitable space around the dwelling for the pipe looping. Energy savings are dependent upon the type of system being replaced and the way the system is operated by the homeowner.

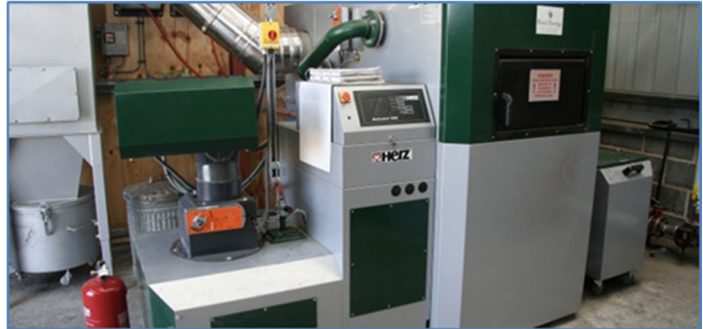
Biomass heating systems burn fuels, considered carbon neutral, to heat the water required for a dwelling. There are a large variety of systems available, and choice depends on the type of fuel to be burned and the level of automation.

The system would offset the energy demand from the hot water and main space heating. However, biomass systems typically require a large amount of maintenance and monitoring.

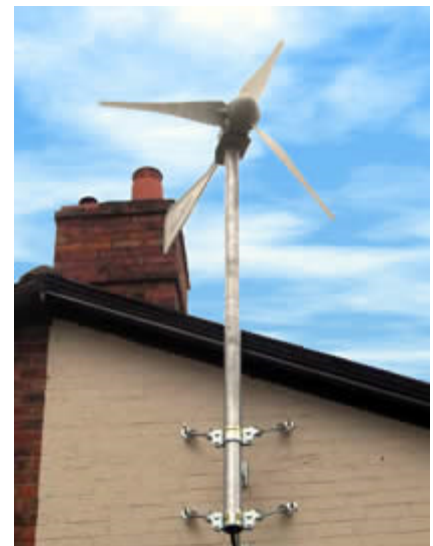
Wind turbines provide electricity directly to a dwelling. They can be added to a property in two ways: pole mounted or building mounted. The pole mounted systems are free standing and therefore require enough space around them to allow for the construction and maintenance of the structure, as well as to allow for efficient operation. The building mounted systems have a lower power output but do not require additional structures, as can be seen in figure

The energy produced from a wind turbine is heavily dependent upon the surrounding landscape. The energy saved will be offset against the electricity usage of the dwelling.
