## Application for Planning Permission

## Sud Brook Garden, Hatherley Road, Tredworth.

# GROUND INVESTIGATION REPORT FOR THE FORMER NORVILLE WORKS, TARRINGTON ROAD, TREDWORTH, GLOUCESTER

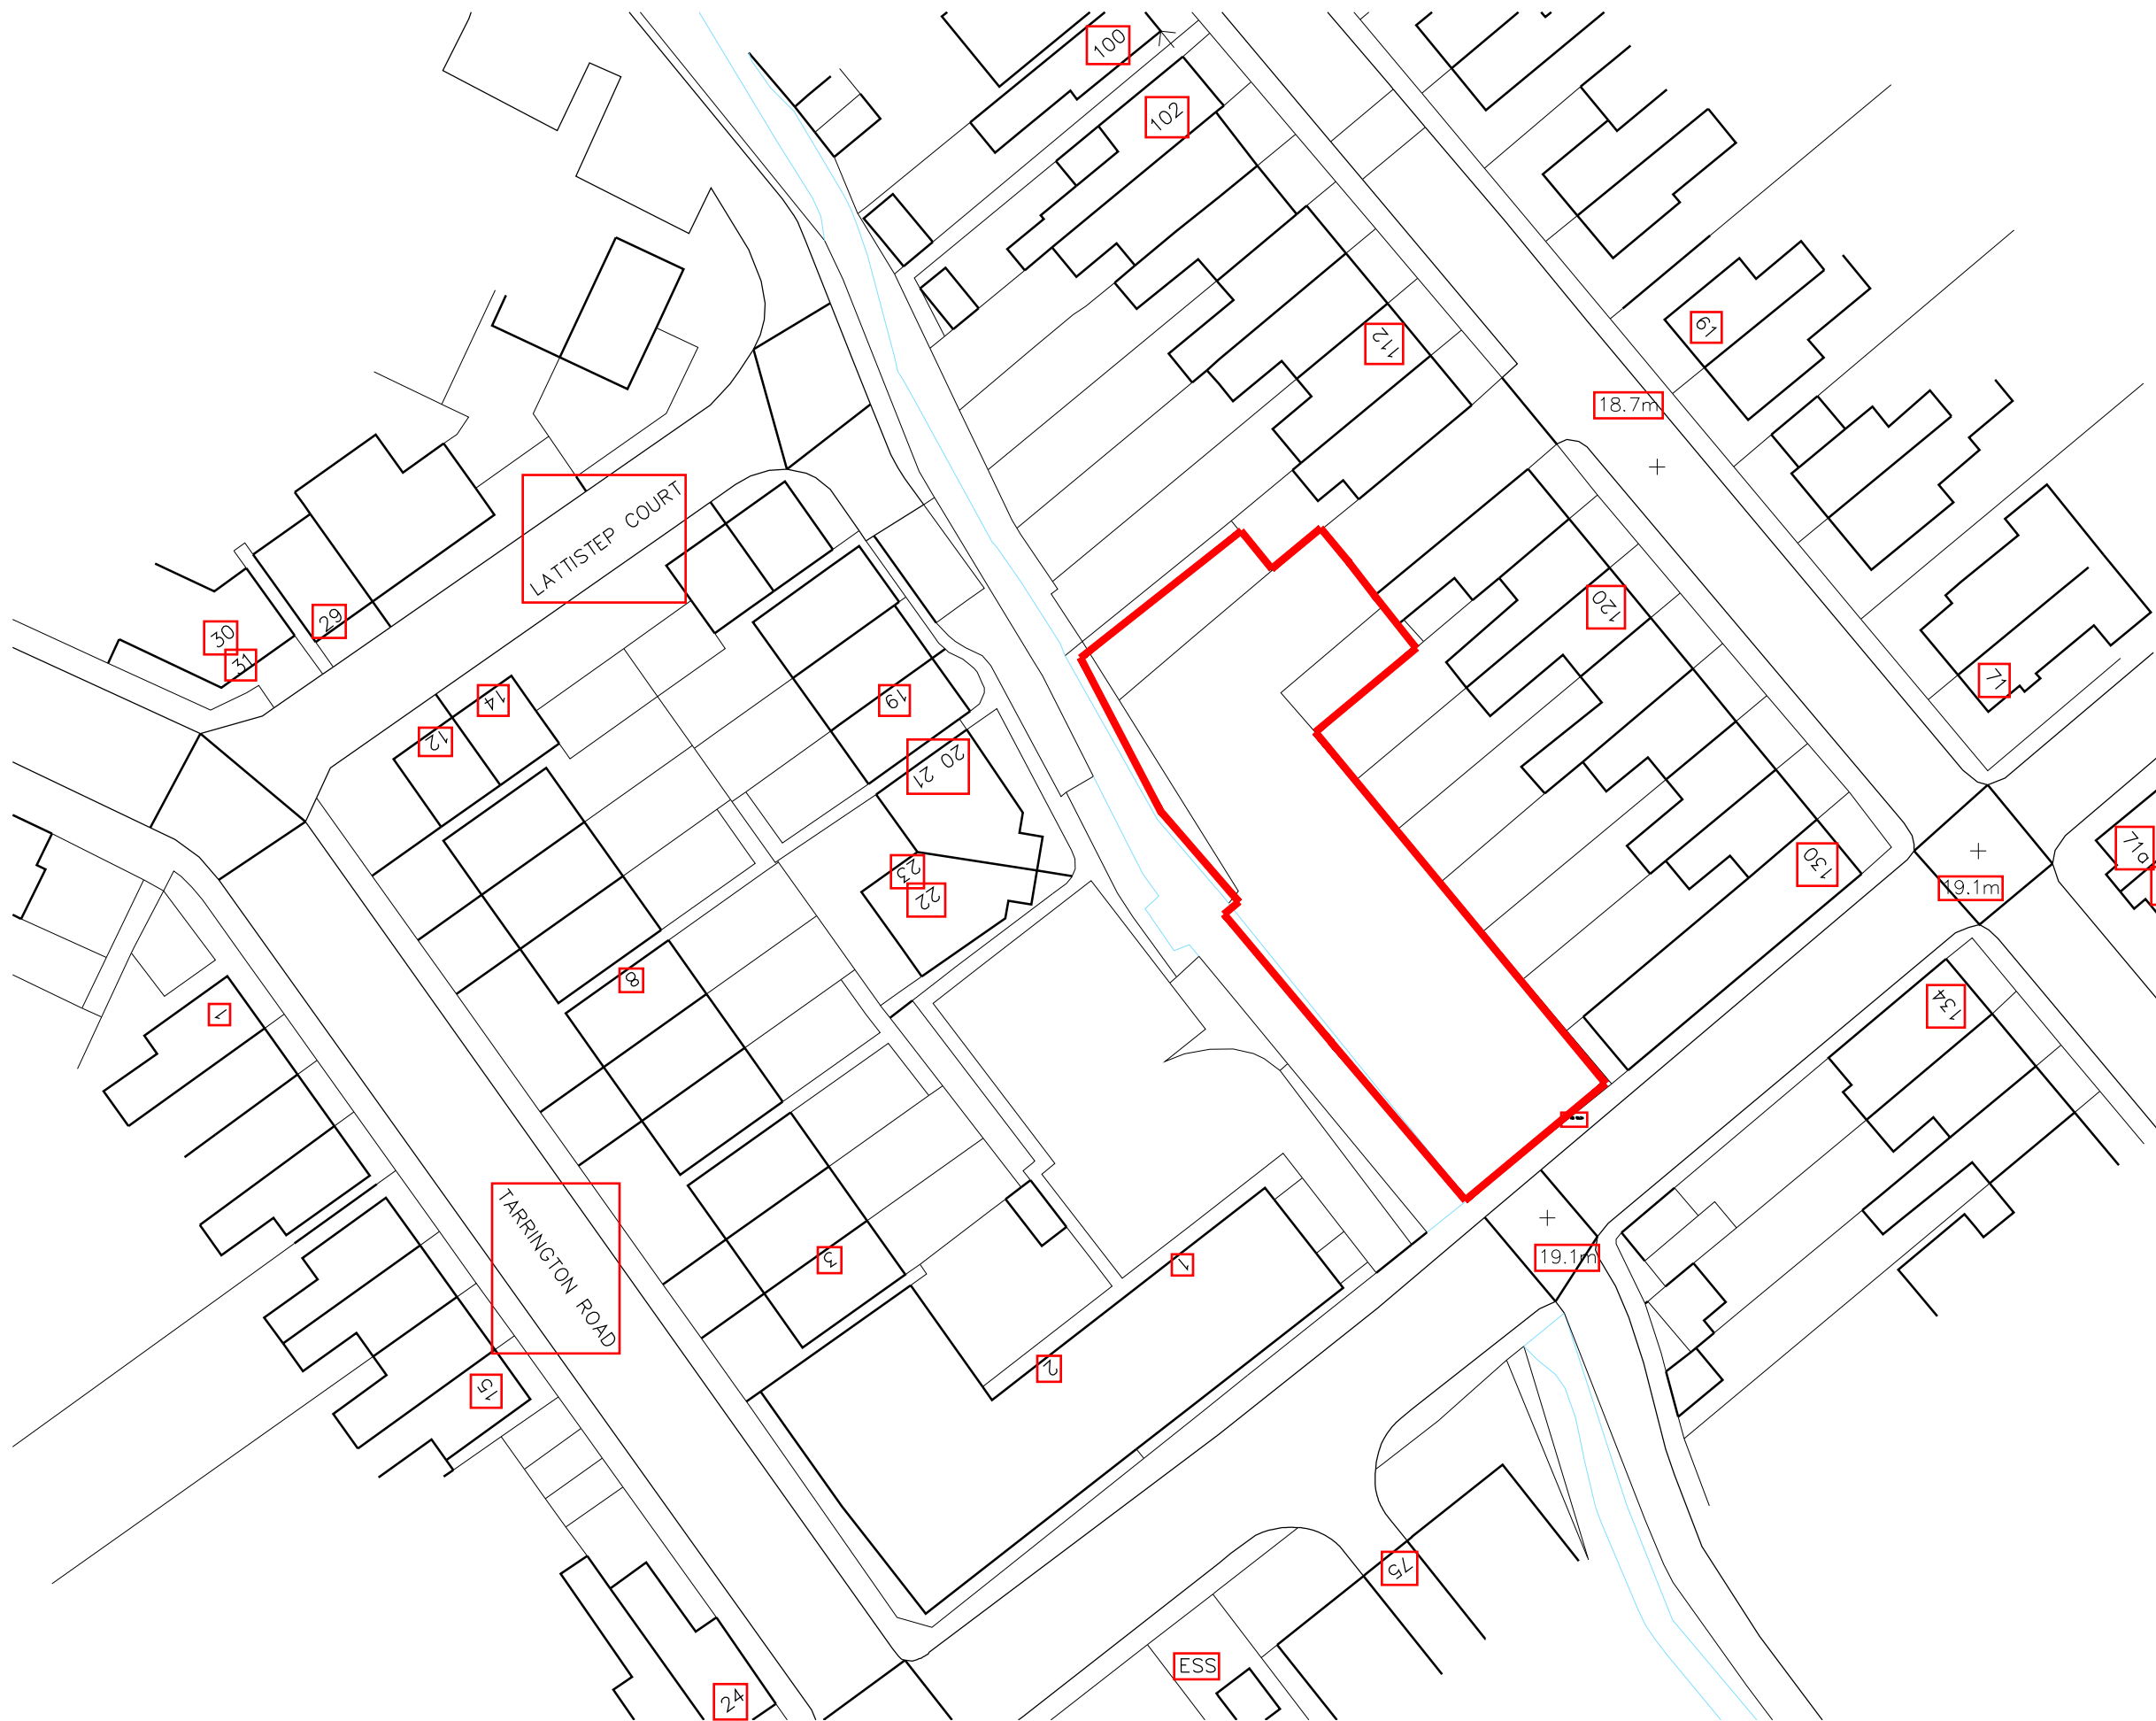
Job No. 70939	Drawing No. D01	Revision -
------------------	--------------------	---------------

## Detail Landscape Plan

- Existing Heritage Wall Retained** - Wall to be retained and made good. Wall to be surveyed and repaired in consultation with Structural Engineer.
  - Steel Gate** - Double entrance gateway to existing wall along Hatherley Road and access from East Gate. Gate to be fixed to wall and the outside. Railing style and back panel coated to match adjacent development.

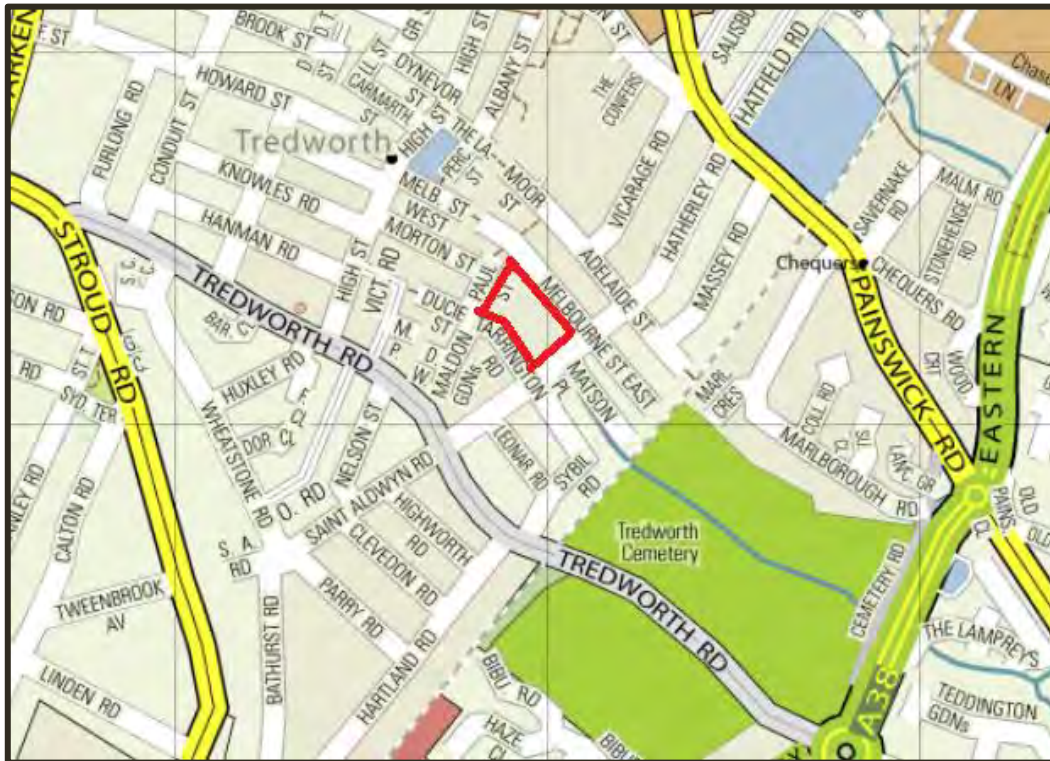
### 3.3 Site description

Norvilles is a disused commercial site that was formally used as a distribution and head office for the Norville optician group. The total area is 8712 sqm 0.87ha and is **virtually all impermeable surfacing either consisting of warehouse buildings or external concrete and asphalt hard standing surfacing.**

Running along the eastern boundary is Sud Brook which is classified as main river by the Environment Agency. To the north west is Paul Street, along the western boundary is Tarrington Road and along the southern boundary Heatherley Road. All these streets are residential.

There are two large warehouse units, of which the larger is the western unit. The north eastern unit is bounded by Sud Brook which runs along its eastern elevation.

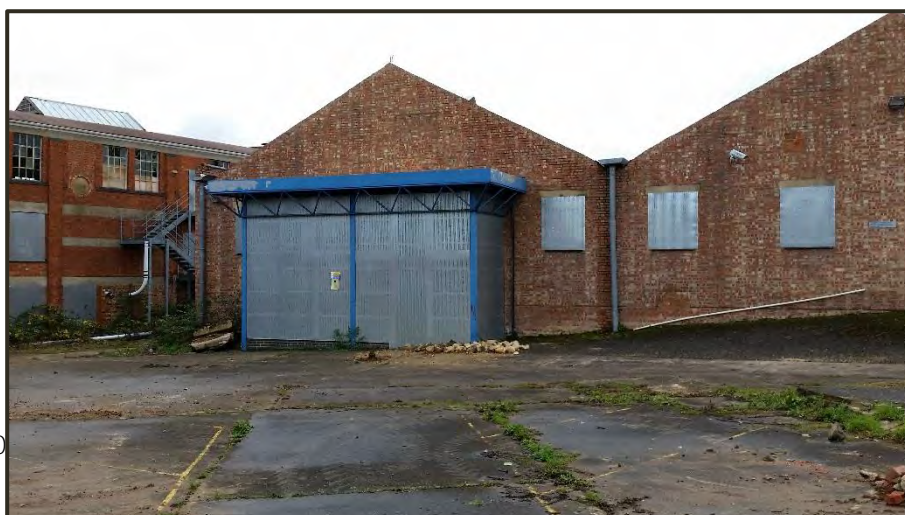
General view of south west Tarrington Road warehouse

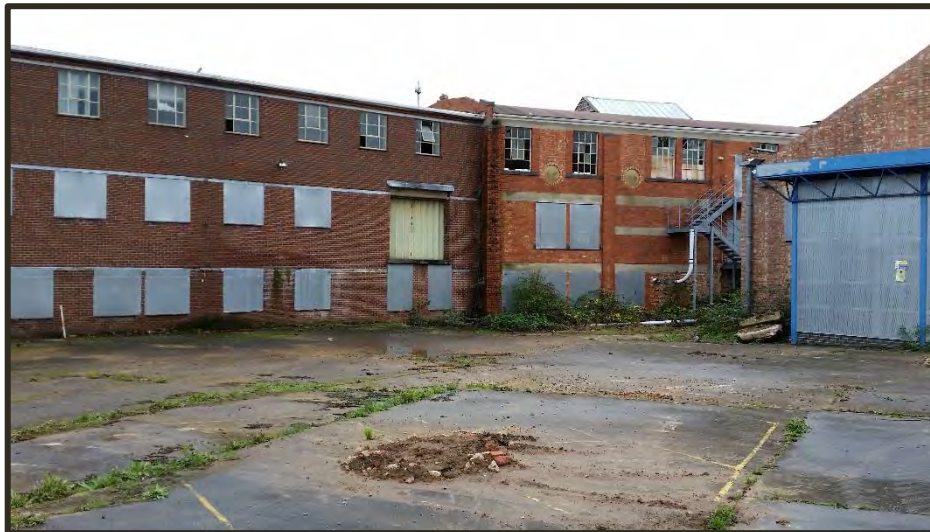
General view of eastern warehouse

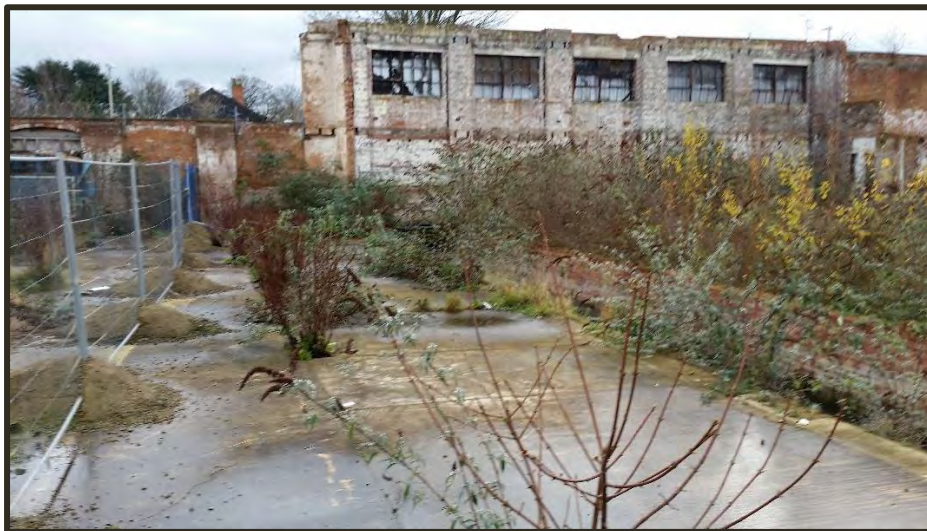
General view of southern warehouse backing on to Hatherley Road

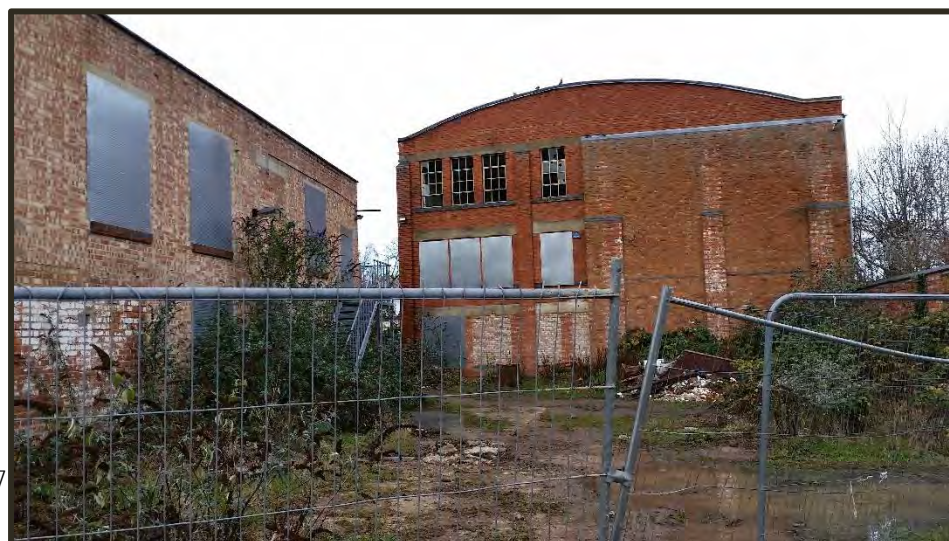
General view of eastern warehouse gable backing on to Sud Brook

It should be noted that the flood maps show flooding extending into the warehouse that is directly adjacent to Sub Brook. This flooding is not possible in reality as the wall of the warehouse forms a solid boundary/ barrier preventing floodwater from entering the site. In addition the slab level of the warehouse is in the order of 1000mm above the modelled level showing that the extent of flooding is incorrect in that area. Warehouse slab level 19.25mAOD compared to flood levels in the order of 18.33mAOD.

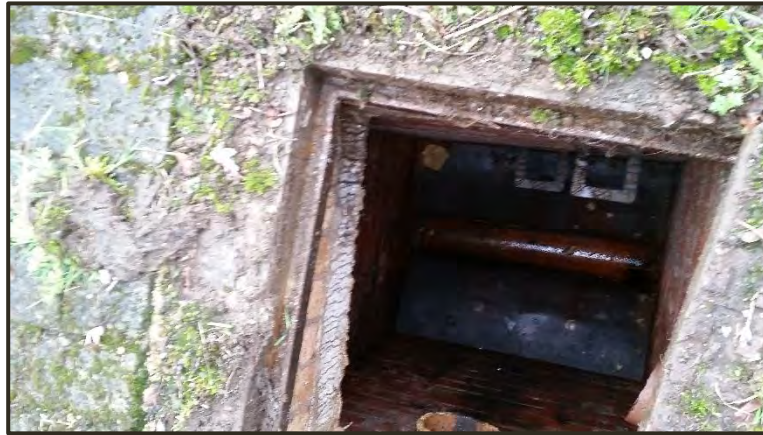
Photo showing surface water drainage system that discharges into Sud Brook

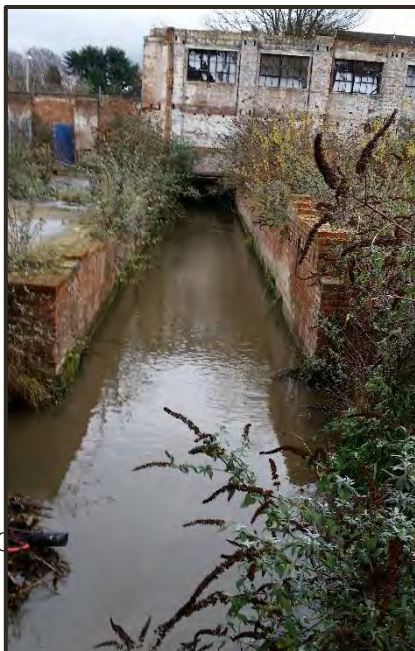
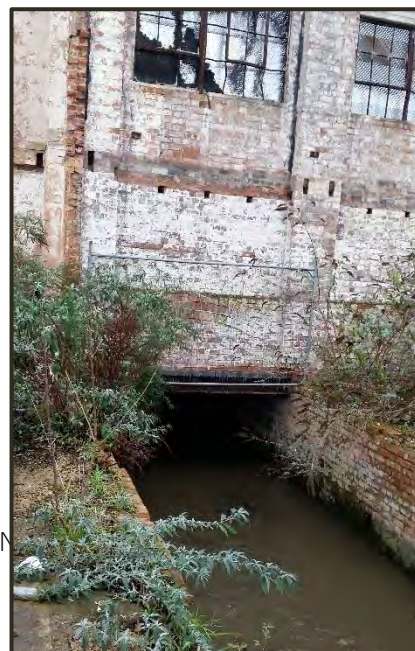
Sud brook and Hatherley Road culvert where brook enters site. Note brick channel walls

Sud Brook, which is classified as a main river watercourse, runs in a south to north direction along the eastern boundary of the site. The brook enters the site via an open span culvert beneath Hatherley Road to the south and then runs within a brick sided channel for a length of approximately 27m prior to meeting a diagonal weir where there is a cascade to a lower level. The brook then runs via a channel for approximately 14m beneath the floor slab of a now demolished building.

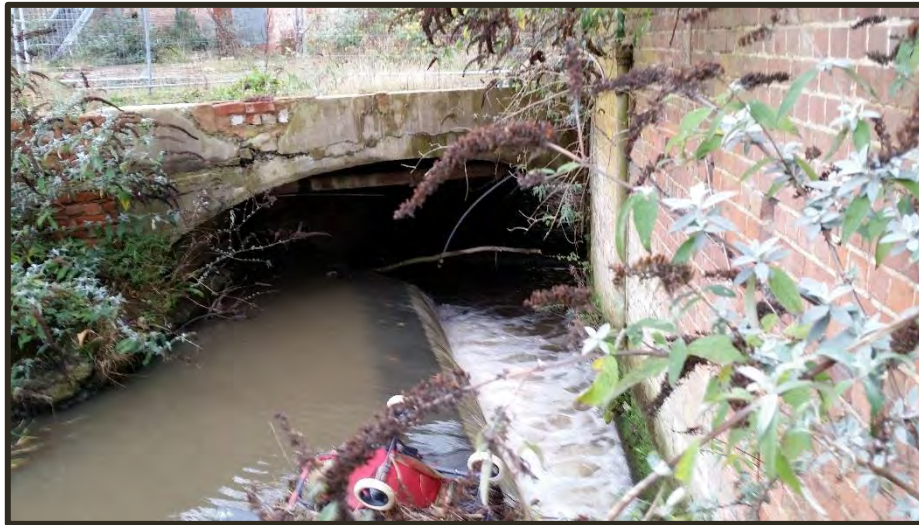
Weir and demolished building slab crossing (building slab to be removed).

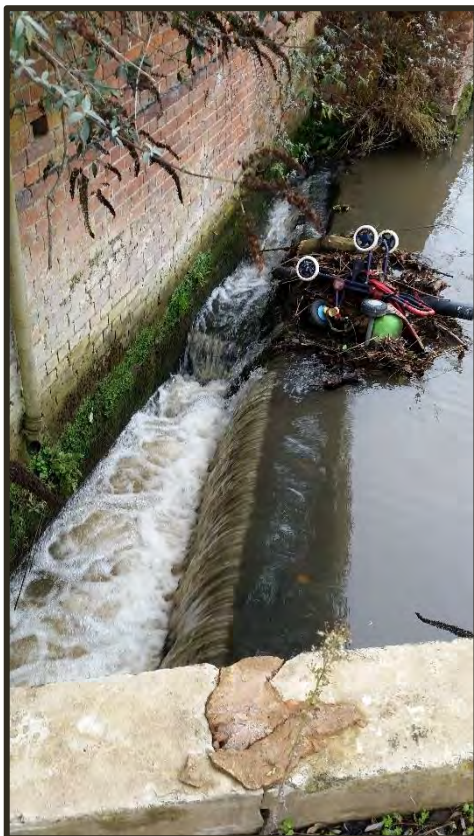
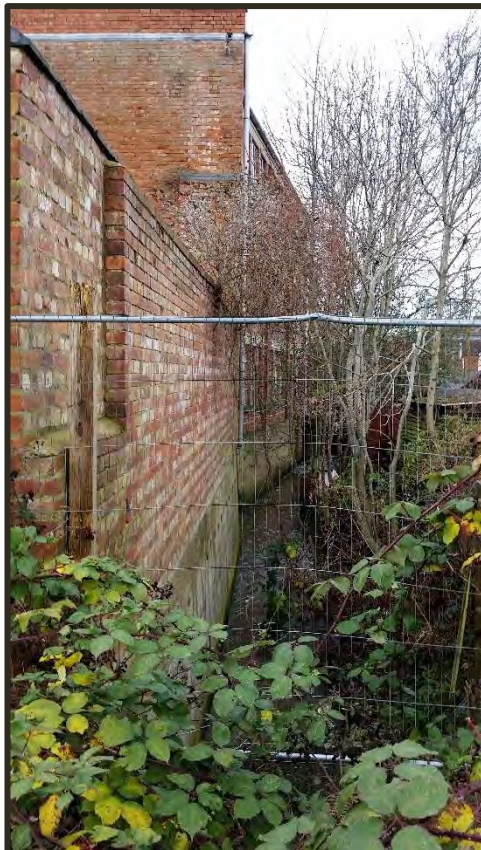
Weir looking south

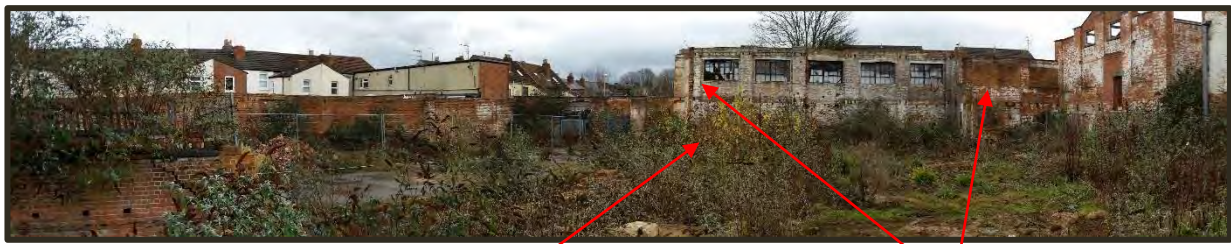
Culvert emerges

Remnants of Hatherley Road elevation indicating extent of demolished warehouse

The exception is the end flat of flats 01-18. It should be noted that where this flat is located there was previously a warehouse building which has since been demolished. The watercourse was culverted beneath this building so the encroachment of the flood zone 3 as indicated on the flood map into this area is in view of this information doubtful. The calculated 1 in 100 year +CC flood level in this area is 18.75 – 18.85 compared to the previous slab level of 18.70. Given the flood level has a climate change allowance it is doubtful that this area was subject to flood zone 3 flooding. The new proposals now liberate much of this area for flood storage as the footprint of the warehouse was far greater than the proposed dwellings.

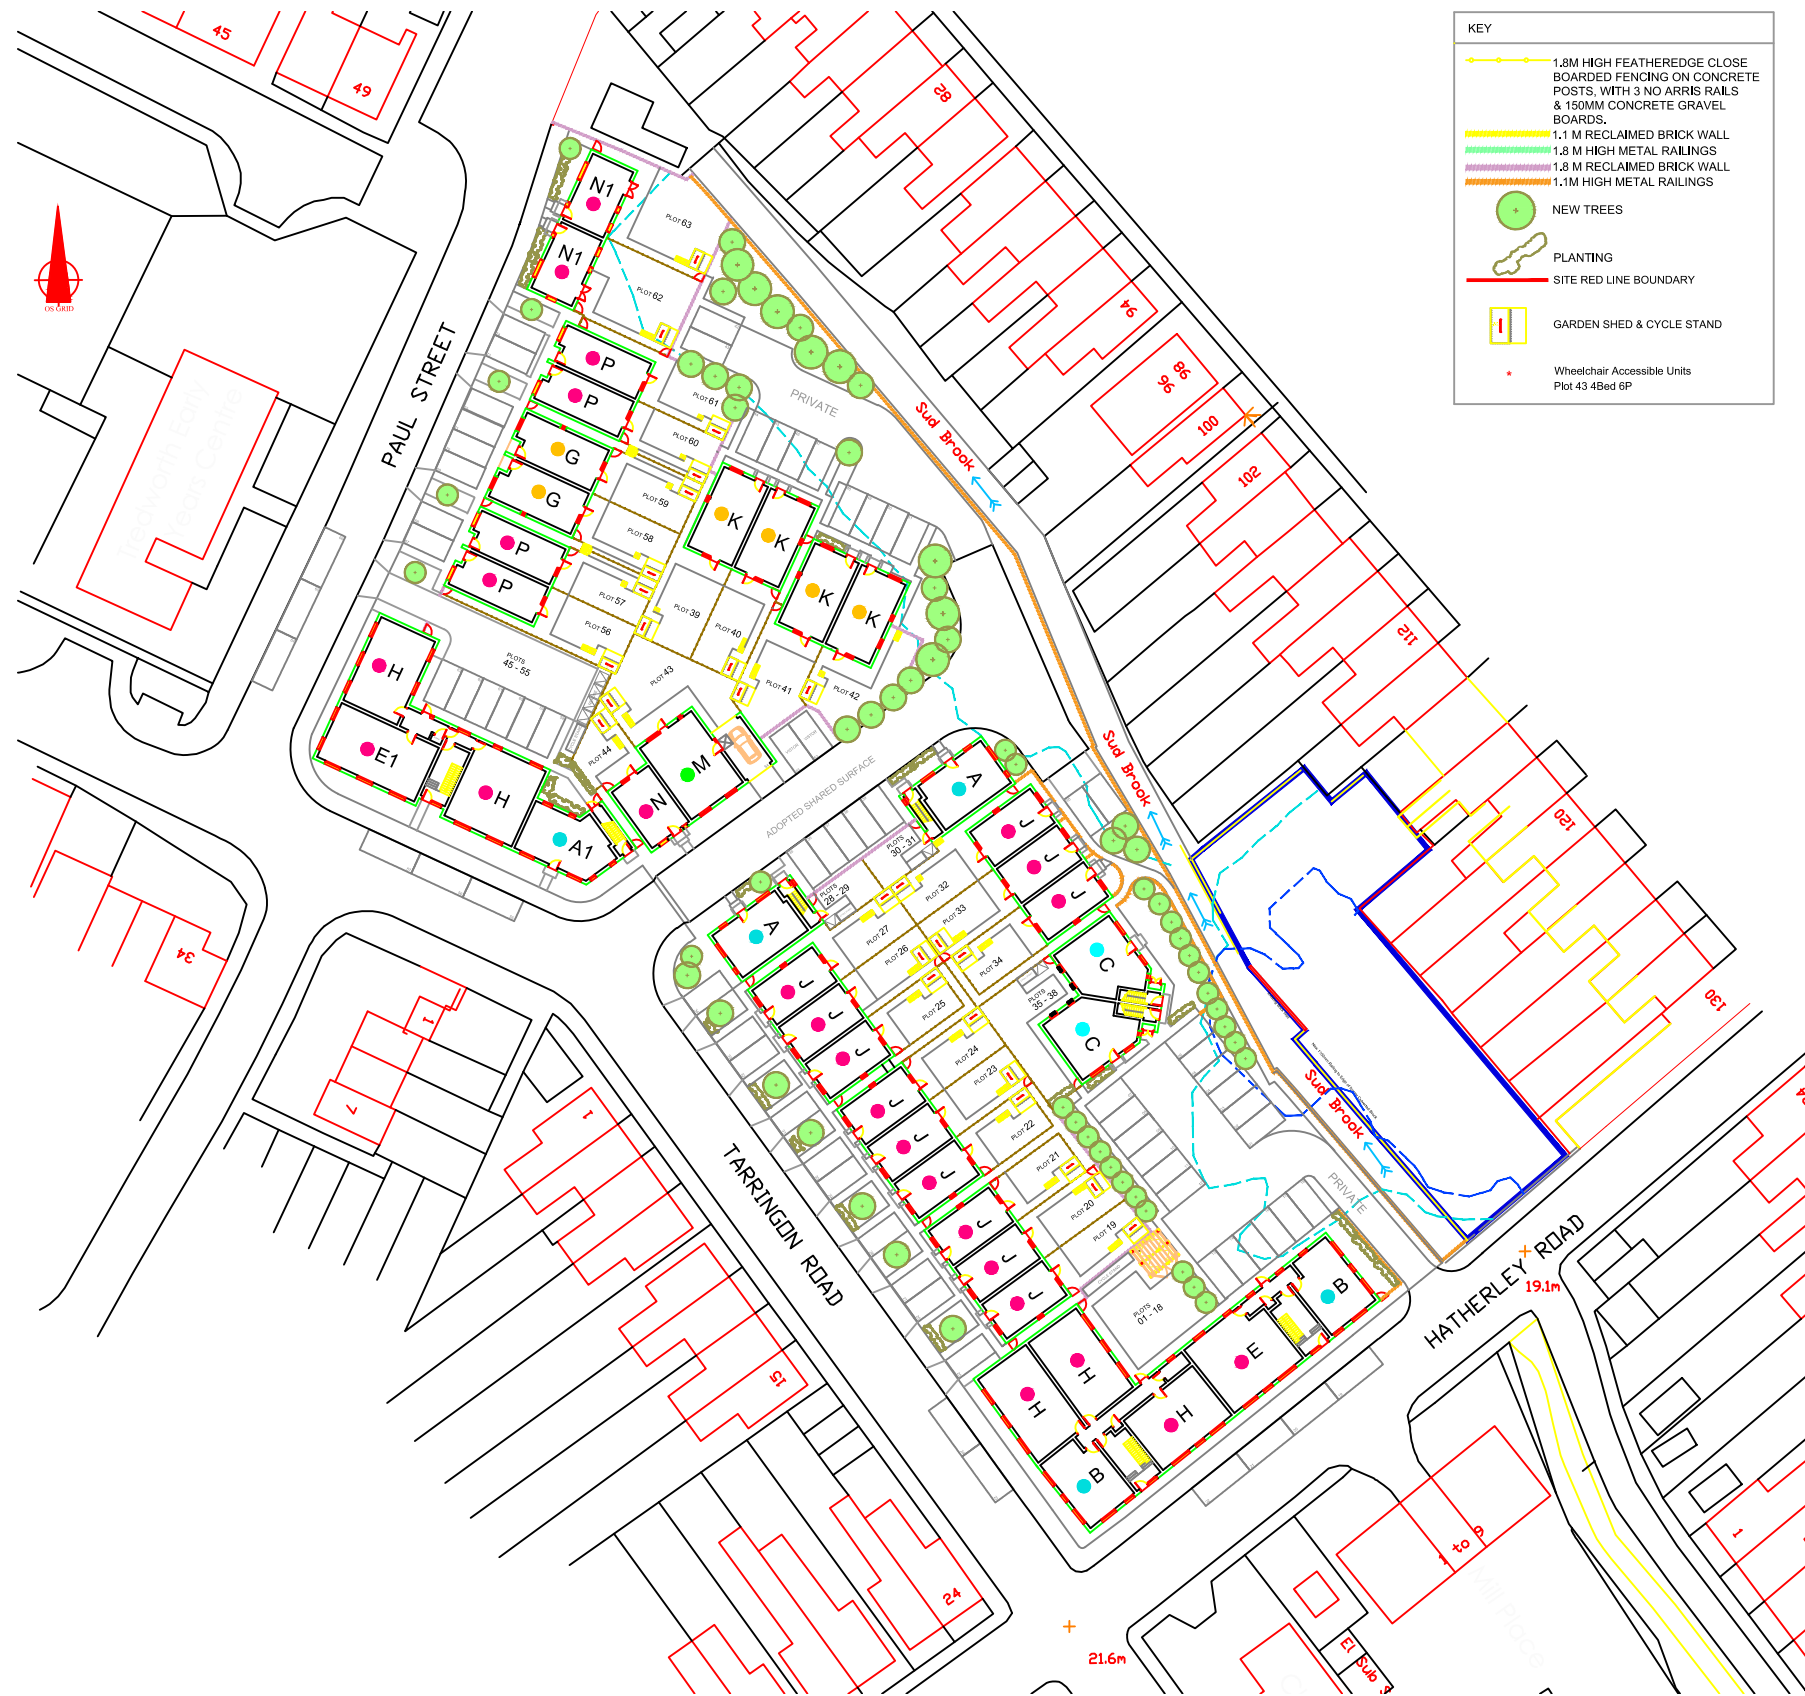
**SITE LAYOUT PLAN** Scale 1:500

Schedule of Accommodation			
Units			
Ref	Unit Type	Area m <sup>2</sup>	No.
Type A/A1	1B/2P Flat	46 - 52m <sup>2</sup>	6
Type B	1B/2P Flat	50 - 55m <sup>2</sup>	6
Type C	1B/2P Flat	51 - 52m <sup>2</sup>	4
Type E	2B/4P Flat	70.0m <sup>2</sup>	5
Type E1	2B/4P Flat (Disabled)	70.0m <sup>2</sup>	1
Type H	2B/3P Flat	62 - 68m <sup>2</sup>	15
Type J	2B/3P House	70.0m <sup>2</sup>	12
Type N/N1	2B/3P House	70.0m <sup>2</sup>	3
Type P	2B/4P House	78.5m <sup>2</sup>	4
Type K	3B/5P House	93.6m <sup>2</sup>	4
Type G	3B/5P House	85.4m <sup>2</sup>	2
Type M *	4B/6P House (Wheelchair accessible)	140.0m <sup>2</sup>	1
<b>Total Units</b>			<b>63</b>
<b>Site Area (m<sup>2</sup>)</b>			<b>7753</b>
<b>Site Area (ha)</b>			<b>0.7753</b>
<b>Residents Parking</b>			<b>60</b>
<b>Visitor Parking</b>			<b>2</b>
<b>On-street Parking</b>			<b>12</b>
<b>Total Parking</b>			<b>74</b>

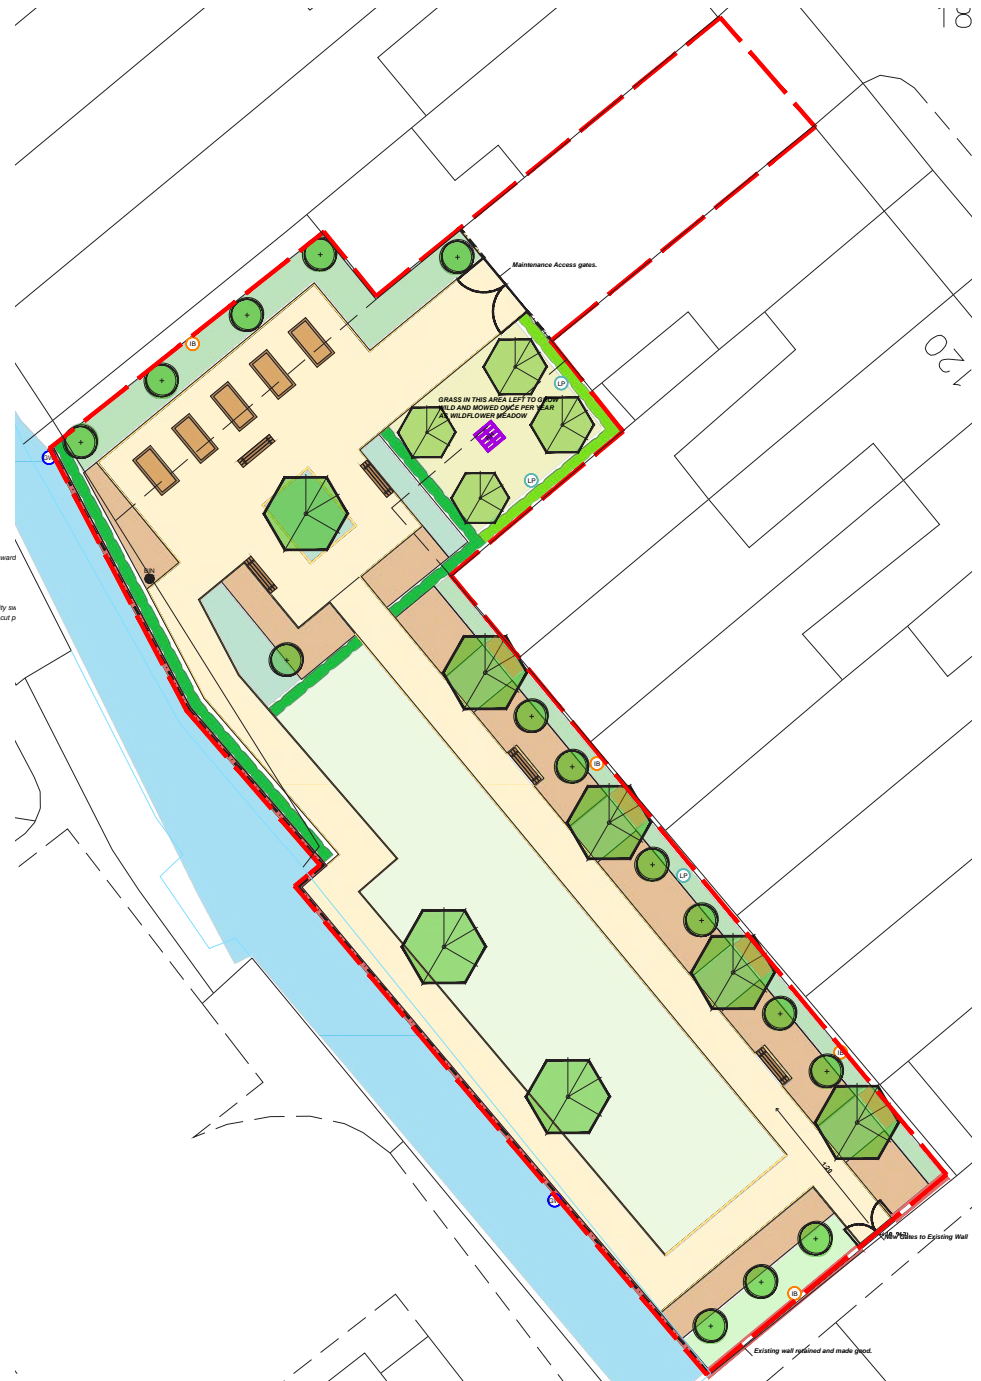
<b>Foot paths</b> - Self-binding (Breedon) gravel paths.
	<b>Timber Edging</b> - Treated timber edging, fixed to stakes at 1.5m centres. Timber pressure treated for external use - D 150mm x W 22mm.
	<b>Retaining Wall with Railing</b> - Existing retaining wall to edge of brook. 100mm gap and with 1000mm height railing fixed to top of wall. Railing style and black powder coated to match adjacent development. Constructed to Engineers specification and details.
	<b>Existing Heritage Wall Retained</b> - Wall to be retained and made good. Wall to be surveyed and repaired in consultation with Structural Engineer.
	<b>Steel Gate</b> - Double entrance gateway to existing wall along Hatherley Road and Access from East. Gate to be fixed to wall and be lockable. Railing style and black powder coated to match adjacent development.
	<b>1800mm Height Steel Railings</b> - Steel railings to secure access from Melbourn St East. Black powder coated to match adjacent development.

<b>Sud Brook</b> - Existing brook, retaining culvert walls to be partially reconstructed subject to consultation with engineers.
	<b>Litter Bin</b> - Greengate Litter Bin, circular galvanised steel litter bin with a raised lid, roof fixed to manufacturer's recommendations. Clad in treated vertical timber slats. H: 700mm x D: 384mm. Supplier - External Works or similar approved.
	<b>2 no. Grey Wagtail and Dipper Nest Box</b> - Boxes fixed to retaining walls along Sud Brook. Vivaro Pro Woodstone Grey Wagtail and Dipper Nest box or similar approved. Supplier: NHBS or similar.
	<b>3 no. Log Pile</b> - Old log, various sizes from various species; also stones, old bricks etc. in a shady area undisturbed, piled up randomly, bark left on if possible.
	<b>4 no. Insect Block</b> - Boxes fixed to existing boundary treatments. Woodstone Insect Block. Supplier: NHBS or similar approved.
	<b>1 no. Bug Pallet Hotel</b> - Multi-storey pallets filled with various natural materials to provide habitat for lots of species. See R2B2R - Build a Bug Hotel guide. Potential for community engagement, local school, charity or residents to help build it.

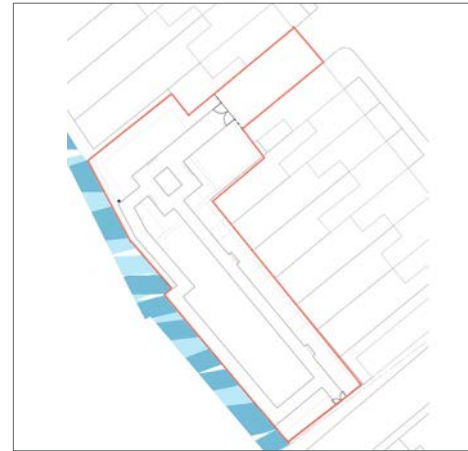
## Sud Brook

The Sud Brook watercourse has been enhanced as part adjacent development. We propose creating a safe and approachable edge with railings to allow users of the garden to interact and enjoy the brook. Nesting boxes for Grey Wagtails will provided to further encourage this species, which currently frequents the location.

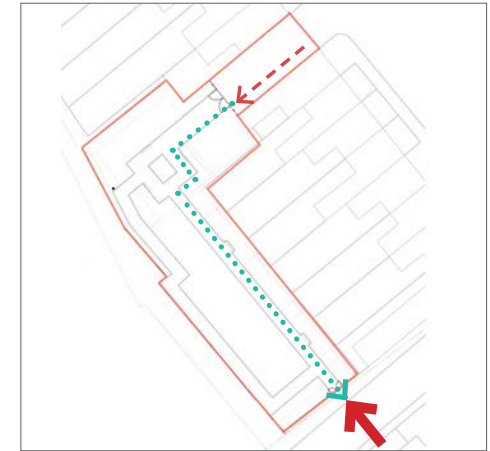
## Entrances & Access

The site will be access from both Hatherley Road and Melbourne Street East, with primary access envisaged from Hatherley Road through the retained heritage wall.

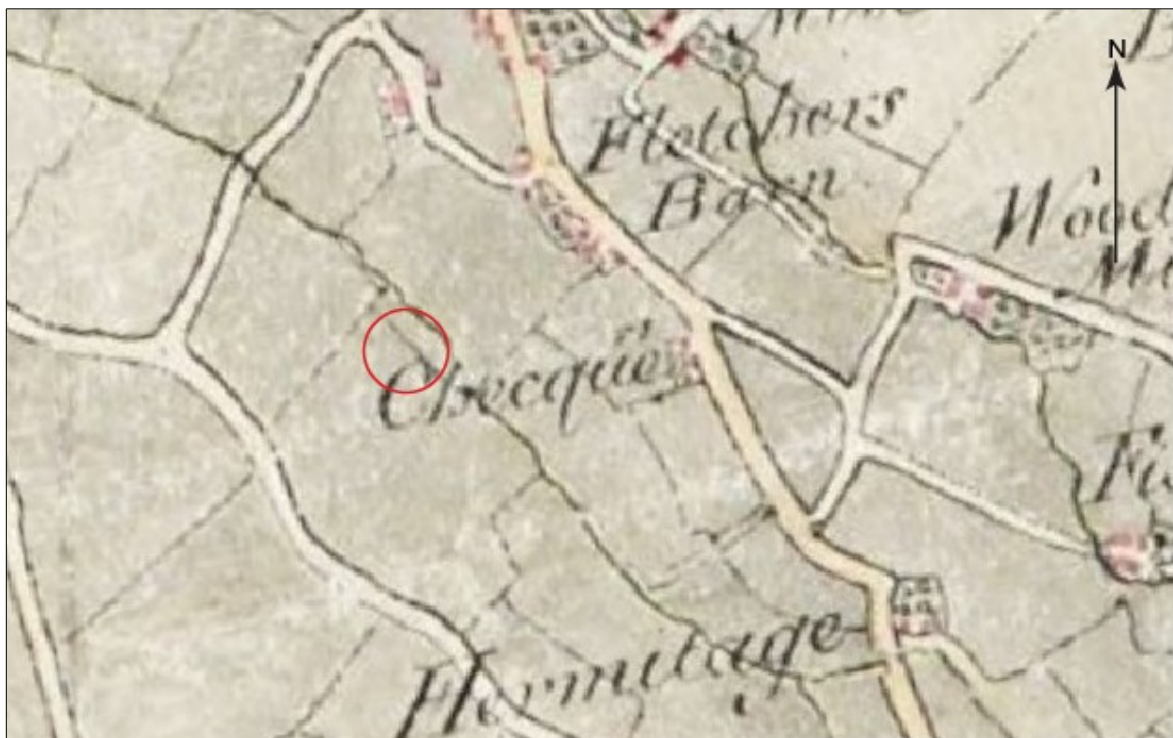
Fig. 3: Fig. 3: Extract from an OS surveyors drawing of Gloucester and district dated 1811(Reproduced by courtesy of Gloucestershire Archives)

An Ordnance Survey drawing of Gloucester and its suburbs surveyed by Lt. Robert Dawson R.N. in 1811 (Figure 3) provides a somewhat simplified depiction of the field enclosure pattern in the vicinity of the site. The study area is shown as lying within the northern part of a large irregularly shaped field bordered to the N by the Sud Brook and to the S by Tredworth Road. Limited evidence of settlement activity is depicted along Barton Street to the N of the Sud Brook, including the Chequers Inn and a group of cottages located further to the NW on the S side of Barton Street.

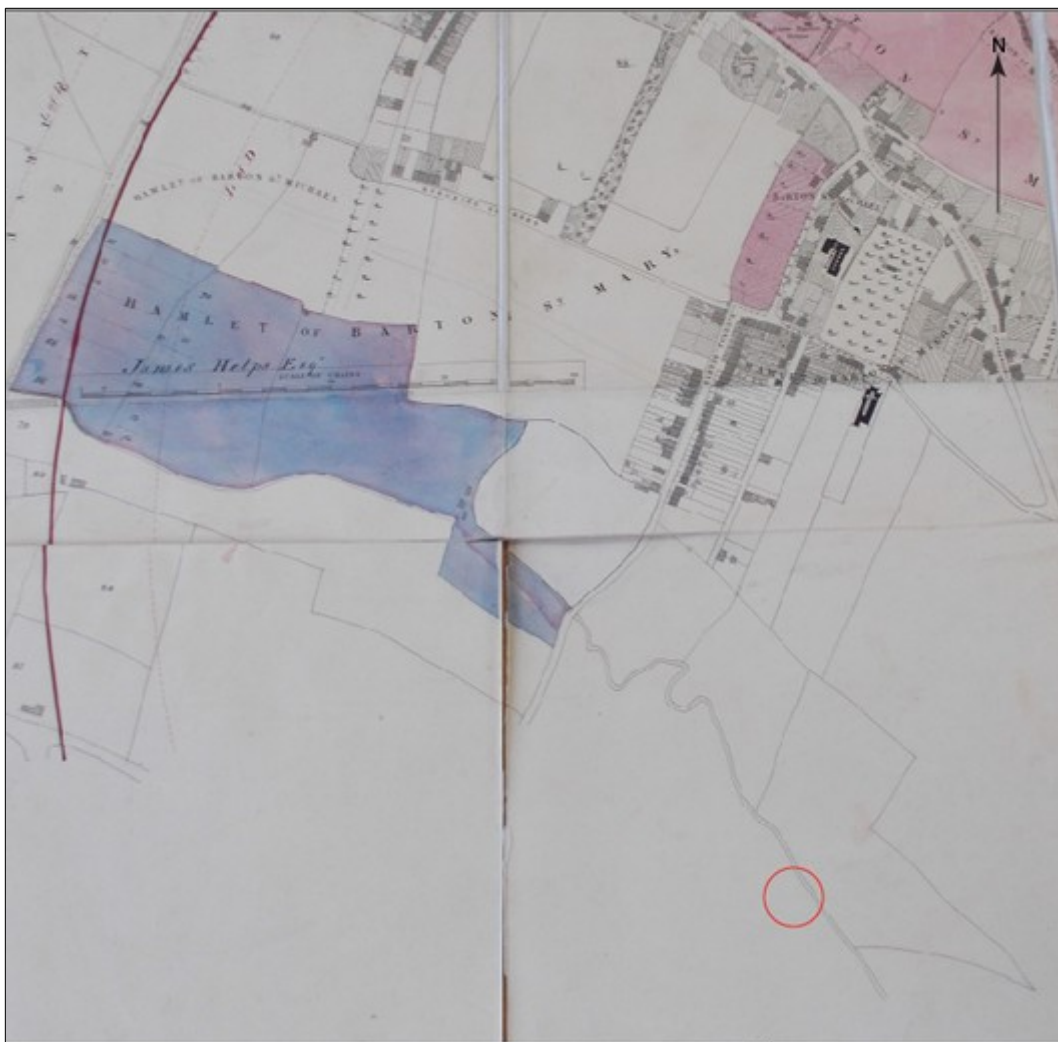
Fig. 4: Extract from an enlarged version of Causton's Map of Gloucester (1843) showing the estates of Thomas Helps in the Barton Street suburb of Gloucester (Reproduced by courtesy of Gloucestershire Archives)

Causton's detailed map of the borough of Gloucester, surveyed in 1843, unfortunately only covers part of the Barton Street suburb to the N of the Sud Brook (Figure 4). A slightly enlarged version of the map, which appears to have been drawn up to show lands belonging to James Helps Esq (son of Richard Helps senior), shows lands to the SW and SE of Barton Street but unfortunately does not extend its coverage to include lands to the S of the Sud Brook. Causton's map shows limited housing development extending southwards along both sides of Barton Street, however the character of the Barton Street suburb was still predominantly rural at that time.

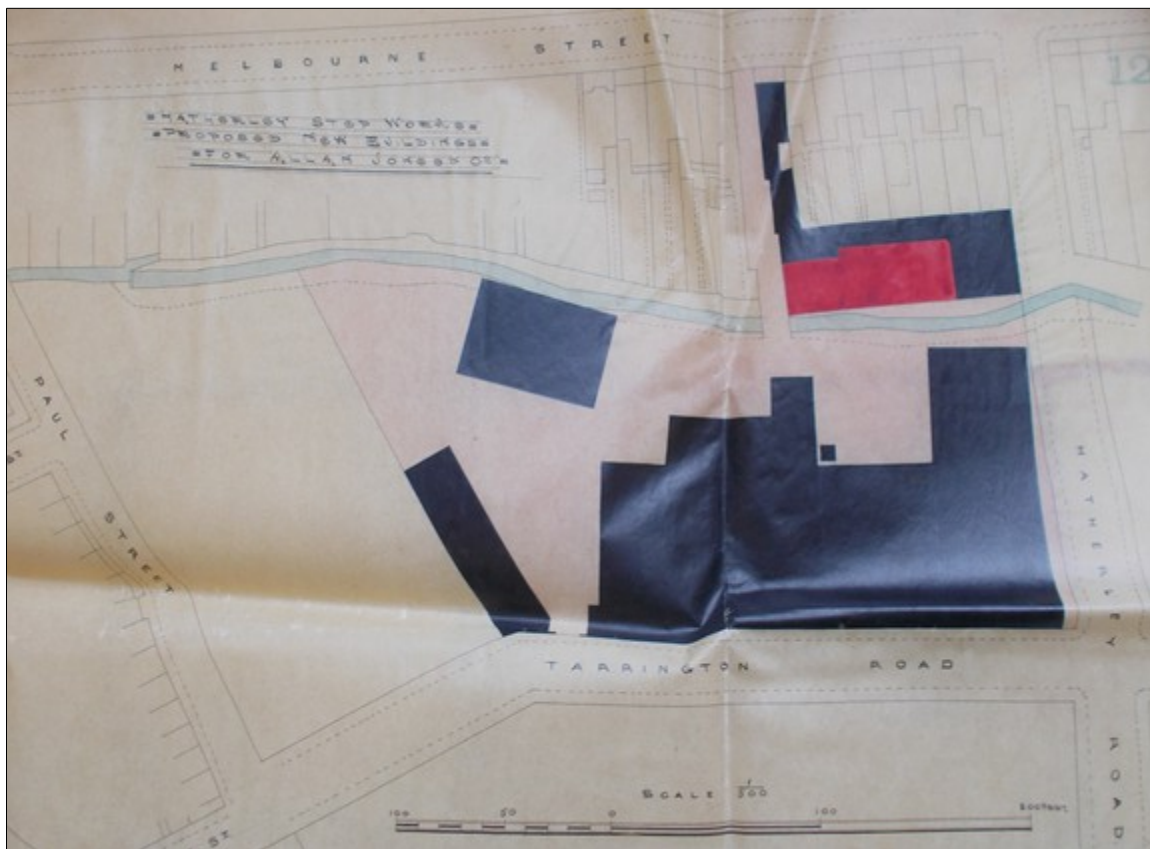
Fig. 7: Extract from a planning application dated 1897 relating to proposed new buildings at the Hatherley Works (denoted in red)(Reproduced by courtesy of Gloucestershire Archives)

In 1897, a planning application was granted for the construction of new buildings on the works site, consisting of a range of new stores constructed adjacent to what is marked on the application plan as the 'Old Mill', located on the S side of Melbourne Road and immediately N of the Sud Brook. It appears that the mill had been relocated to the S of the Sud Brook, with a bridge providing access the brook from the new mill to the old mill which had been converted into a storeroom (GA. GBR/L20/2/1897/55).

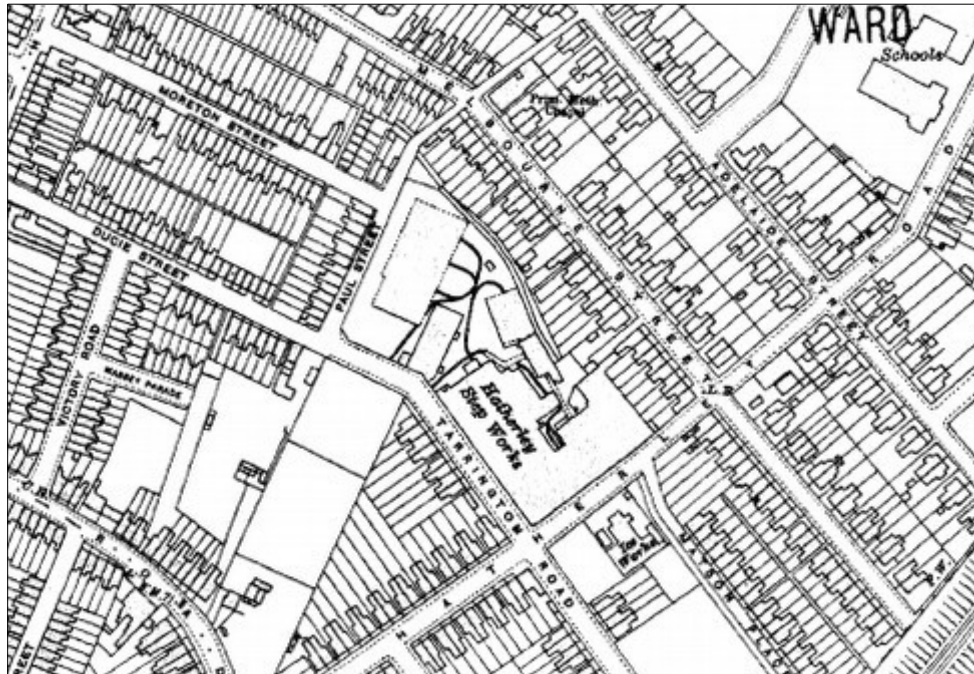
Detailed information as to the layout of the Hatherley Works premises in the early decades of the 20th century is supplied by the OS 2nd edition and 3rd edition 25 inch map of 1902 and 1923 respectively (Figure 8) and plans attached to two building applications relating to additional buildings constructed in 1907 and 1909, supplemented by a brief description of the works buildings dated 1904 and a more

Fig. 8: Extract from the OS 2nd edition 25 inch map of 1902(Reproduced by courtesy of Gloucestershire Archives)

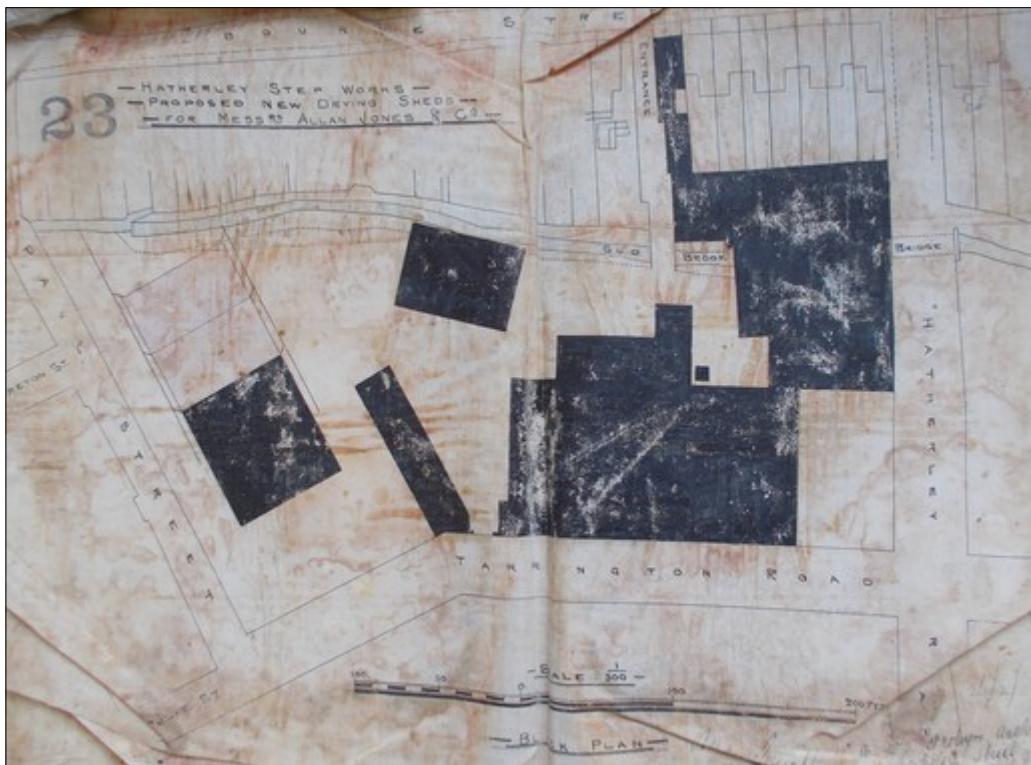
Located separately from the main mill building, adjacent to the Sud Brook, was an ironmonger's store which may be identified with a large rectangular building to the NW of the main mill building that is shown on the plan attached to the 1907 planning application. This building had a blacksmith's forge at

Fig. 9: Planning application map for the construction of new timber drying sheds at the Hatherley Works (1907)(Reproduced by courtesy of Gloucestershire Archives)

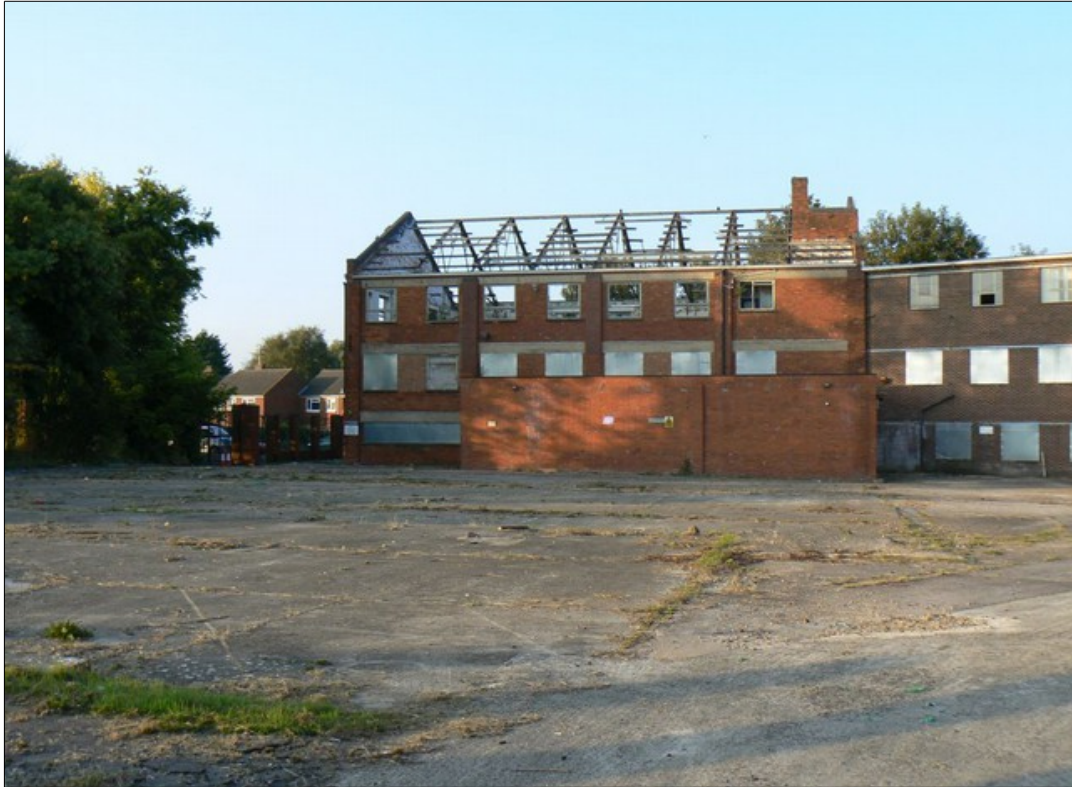
Plate 1: Southern elevation of northwest range of buildings. View - N.

Two site visits were made to the proposed development on the 9<sup>th</sup> of September and the 3<sup>rd</sup> of October 2014. The visit suggests many of the surviving buildings on site date to the 20<sup>th</sup> century, although a small number of late 19<sup>th</sup> structures appear to have survived, some heavily altered by later 20<sup>th</sup> century use.

where it has been inserted. This would probably include any rail/ tramway tracks marked on the 2<sup>nd</sup> and 4<sup>th</sup> edition OS maps, and may also have impacted on any earlier foundations in these areas (Plates 1 and 2).
