## Application for Planning Permission

## Sud Brook Garden, Hatherley Road, Tredworth.

# GROUND INVESTIGATION REPORT FOR THE FORMER NORVILLE WORKS, TARRINGTON ROAD, TREDWORTH, GLOUCESTER

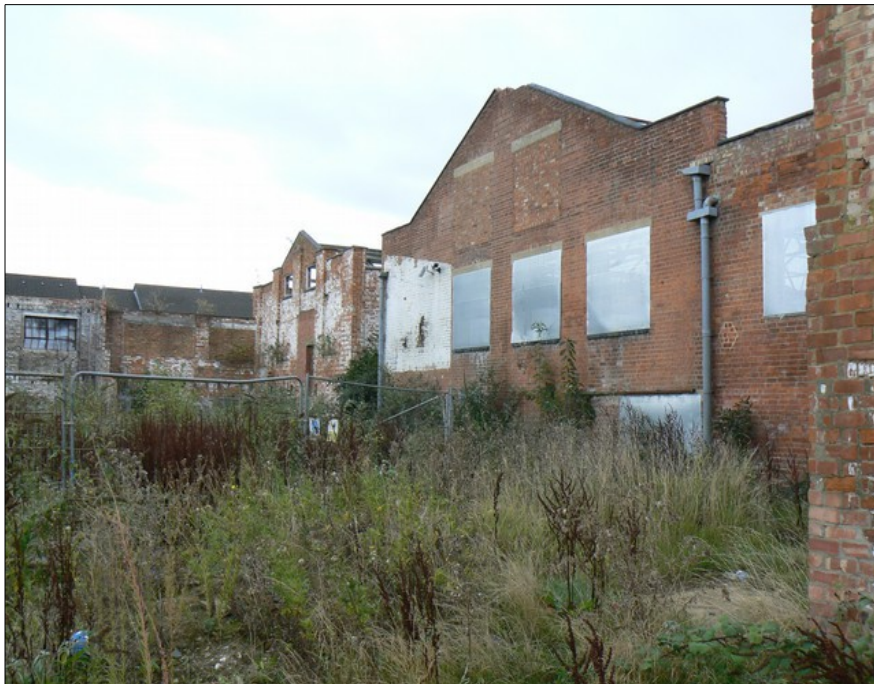
Plate 3: Southern elevations of southern range of buildings. View - SE

The buildings on the site were in a generally poor condition and were in many cases lacking roofs, were lacking in repair and the eastern range of buildings had recently been demolished. The yardage space in between the buildings was covered for the most part in a concrete surface. On the north side of the site this yardage was heavily overgrown. It is likely, given that this yardage is at the probable height of the original ground level and would overlie a bedding material, that its construction may have removed most of the ephemeral evidence for earlier activity within these areas. This would probably include any rail/ tramway tracks marked on the 2<sup>nd</sup> and 4<sup>th</sup> edition OS maps, and may also have impacted on any earlier foundations in these areas. The buildings comprising the eastern range of structures on the site had been subjected to arson in 2012, which had resulted in one of the buildings along the eastern frontage being demolished. This demolition appeared to be quite extensive, with evidence that the foundations for the building had also been grubbed out (Plate 2).

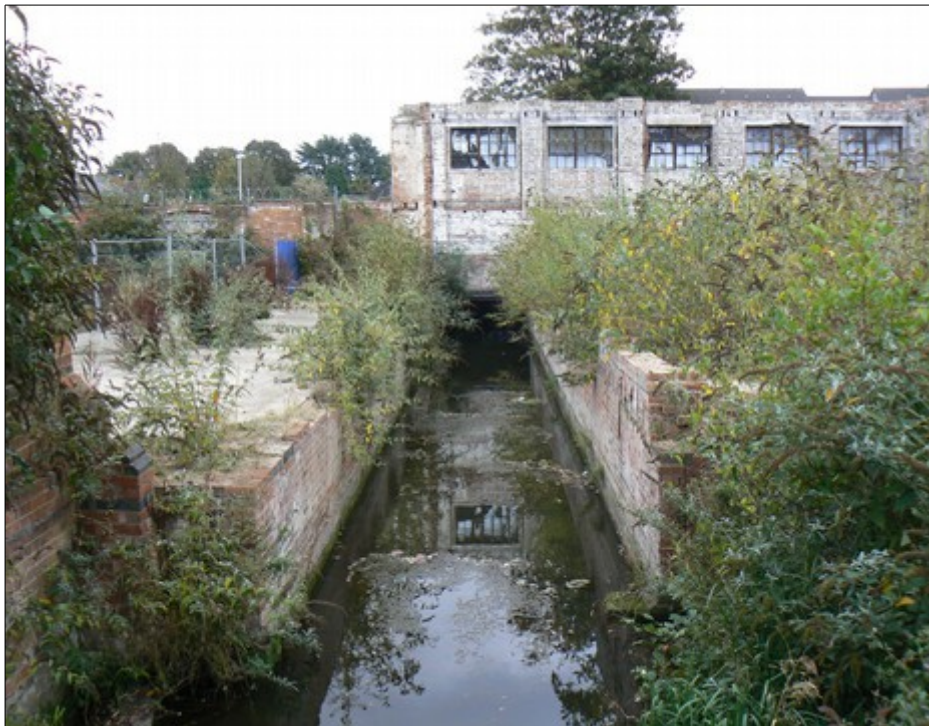
Plate 4: Leat carrying the Sud brook through the site. View - SE

The Sud brook runs through a fairly well preserved brick lined channel across the northern half of the site, overlain in several places by surviving 19<sup>th</sup> and early 20<sup>th</sup> century buildings (Plate 4).

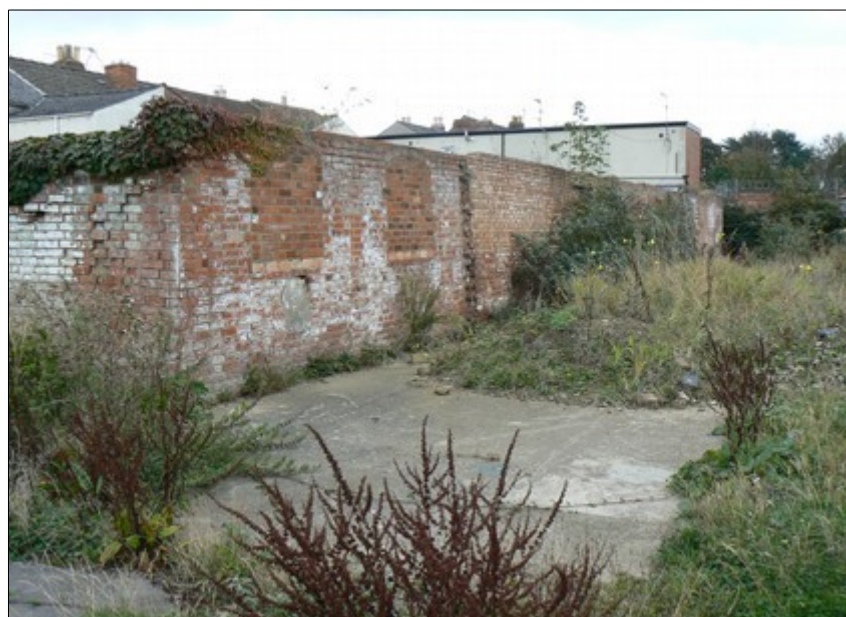
Plate 5: Surviving outer walls of late 19<sup>th</sup>/early 20<sup>th</sup> century structure in northeast quadrant of site. View - E

Part of the outer wall of now demolished late 19<sup>th</sup>/ early 20<sup>th</sup> century structures recorded on early OS mapping in the northeast corner of the site were visible along the rear garden walls of terracing lying north of the site (Plate 5).

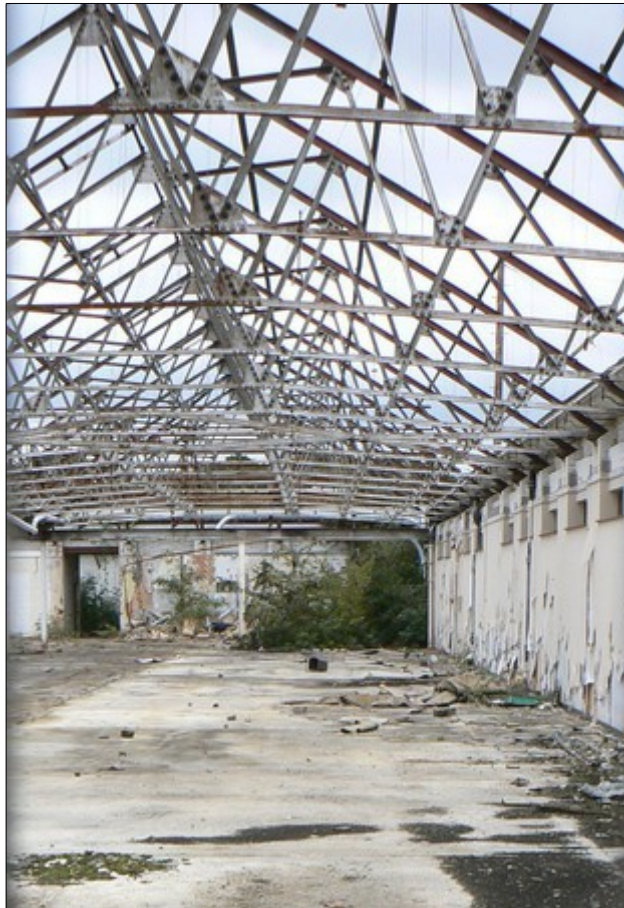
Plate 6: Interior of building in southern range. View - SE

Access to the buildings themselves during either site visit could not be gained due to the structures being sealed off to prevent vandalism, as well as health and safety aspects regarding sharps and unsound structures. Assessing the survival of interior fixtures and fittings where visible through windows and in consultation with the land owner seems to suggest the buildings have been completely stripped of any original fixtures and fittings (Plate 6).

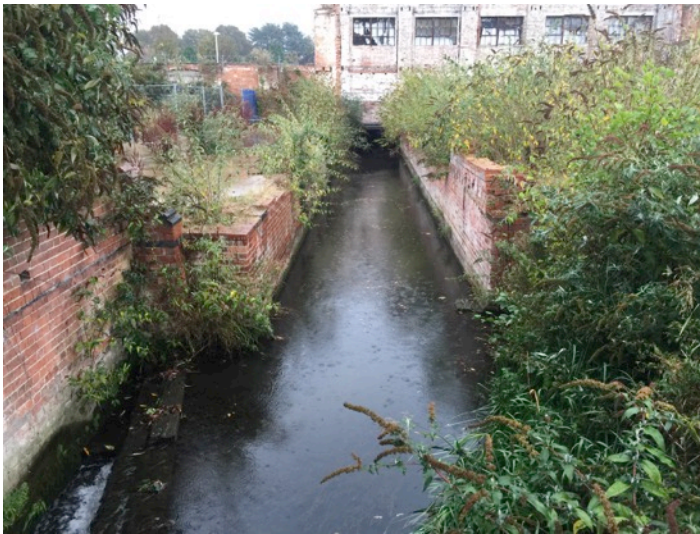
Photograph 6: Running water.

- 3.12 A brick wall channel of running water was present in the east corner of the site. It was approximately 2.5 m wide and 0.5 m deep. There was no aquatic or marginal vegetation although some of the surrounding scattered scrub was overhanging into the water. The flow was from southeast to northwest where a weir was present before the water course went under a bridge and then ran along the northeast boundary of the site before entering into a subterranean culvert.

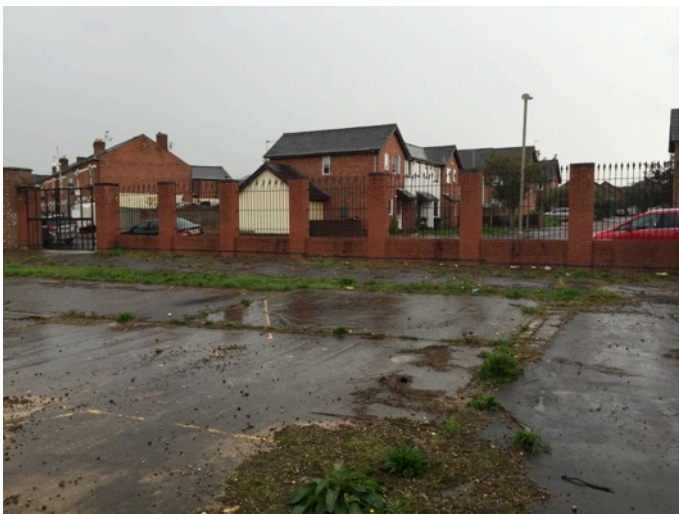
Photograph 7: Perimeter walls and railings.

- 3.13 The boundaries of the site were formed by walls of the factory buildings and low brick walls with brick posts and iron railings.

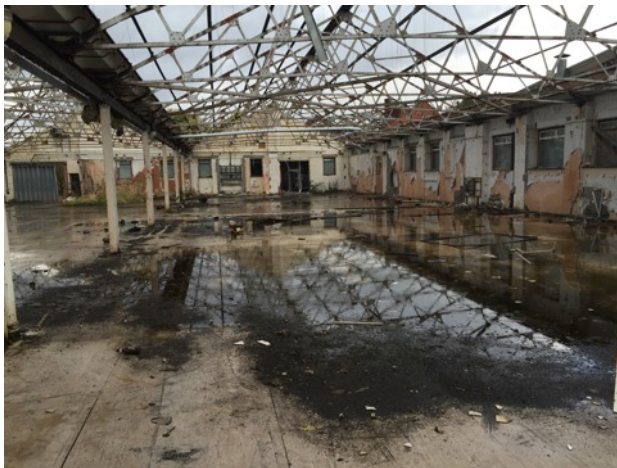
Photograph 8: Main section of Building 1 with missing roof.

- 3.15 Building 1 was a large factory building constructed with brick walls. The roof of the main part of the building and a smaller end section was no longer present and only the steel structure remains. A small section of the building still has a roof of gable end construction formed by steel trusses and covered with corrugated sheet metal. There were no separate roof voids; a basement was also present but no access was available. This part of the building was well lit through numerous window openings. Large accumulations of pigeon droppings were present and the potential for day roosting bats is negligible. A small number of side rooms were also present but these were well lit and also unsuitable for bats. There is potential for the roofed section and side rooms to be used as night roosts or feeding roosts but no evidence such as droppings or feeding remains was found.

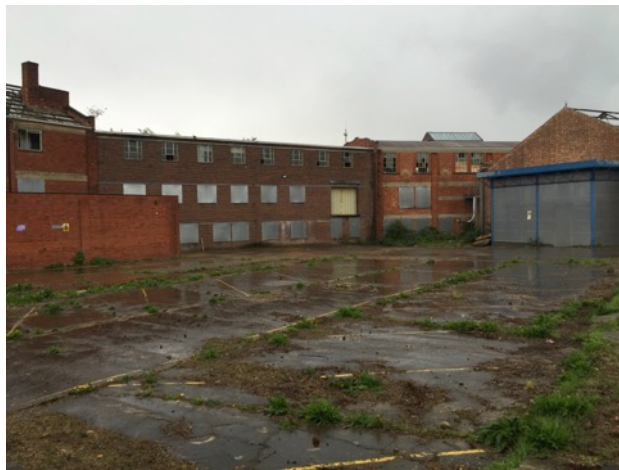
Photograph 13: Exterior view of Building 2.

3.16 Building 2 was a large three storey factory building constructed with brick walls. It was divided into three sections. The north section of the building formerly had a pitched roof of gable end

construction but the roof is now absent and only the gable walls and steelwork remain. The central section has a flat roof and the south section has a shallow arched roof covered with tiles; a central pitched skylight is also present. The eaves are sealed with fascia boards with guttering. The ground and first floor windows are covered with security mesh but the second floor windows are uncovered and the majority are smashed allowing easy access for bats into the interiors. However, there were no separate roof voids with the rooms below open all the way to the underside of the roof. The tiles on the tiled section were sat on sarking boards but no gaps in the tiles were noted that could allow bats into what would be a very minimal void between tiles and boards. The interior was well lit through out with the exceptions of a small number of side rooms and former lavatories. The majority of these were used by pigeons and no evidence of bats was discovered to indicate that these rooms are used by bats for either day or night roosting.

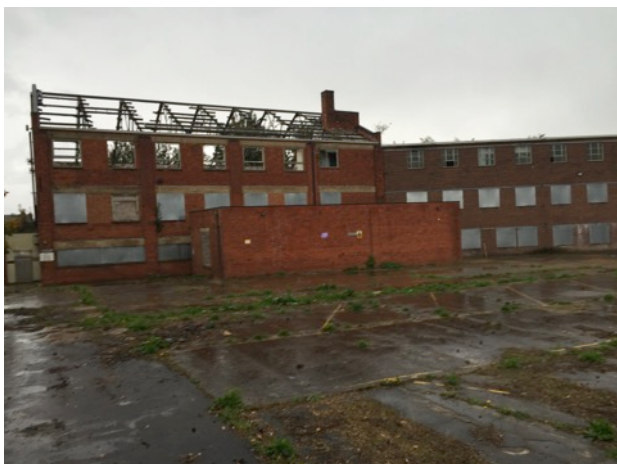
Photograph 17: View of lock up in front of Building 2.

- 3.17 Two brick single storey flat roof lock ups were present next to Building 2. These were not accessible but had no potential entry points for bats, which are therefore likely to be absent from these buildings.

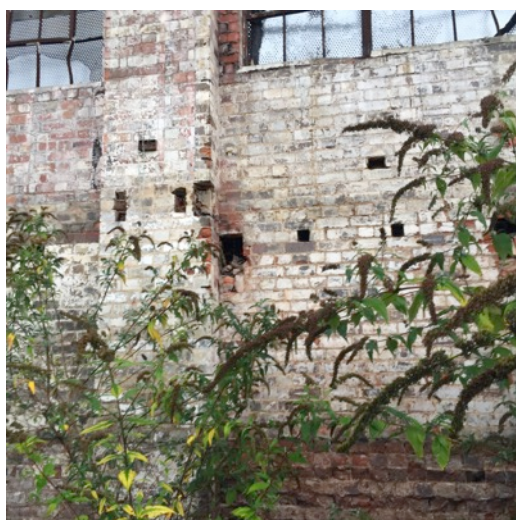
Photograph 18: View of holes in the southeast wall of former Building 5.

- 3.19 Opportunities for hibernating bats are minimal. There are only a limited number of cavities that could be used by species such as pipistrelles and although the basement below the former main building is likely to provide suitable conditions for hibernating bats, no means of entry was noted. There were no other accessible basements or other areas that would be well isolated from extreme temperatures in the winter months.

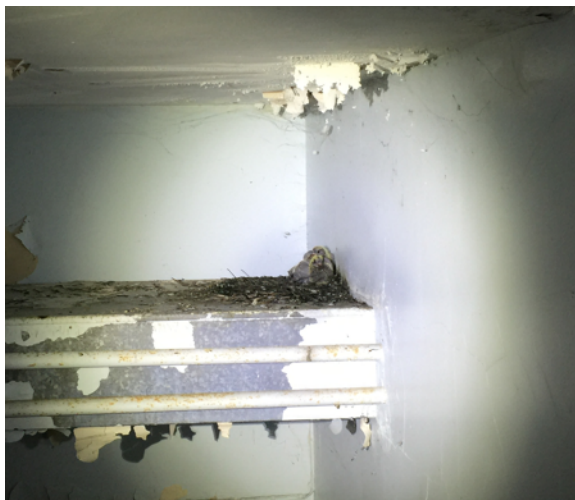
Photograph 19: View of pigeon nest containing three chicks.

- 3.26 GCER provided records of Red Kite, House Sparrow and Starling within 1 km of the site. Woodpigeon and Carrion Crows were recorded on site during the survey as well a number of Feral Pigeons using parts of Building 1 and Building 2. A nest containing three chicks was recorded on a ledge above the main stairwell in Building 2. Other potential nesting sites were present within this building in locations such as the top of old heating ducts and various other ledges and alcoves.
- 3.27 Areas of scrub and trees around the site provide limited potential nesting habitats for urban bird species and the vegetative habitats in general are likely to provide only minimal foraging habitat. The surrounding area is expected to support a variety of urban bird species.

- 4.14 Nesting birds are protected under The Wildlife and Countryside Act 1981 (and amendments), including Feral Pigeons whose nests can only be removed by an authorised person for reasons of health and safety and only when they are satisfied that non-lethal methods of resolving the problem such as proofing measures are ineffective or impractical. As a precaution to avoid delays to the demolition of the buildings, it is recommended that the building interiors are made bird proof by first ensuring that no live birds or active nests remain within, and then sealing entry points such as broken windows. It is recommended that any demolition works and scrub clearance be carried out outside of the bird-nesting season of March to August. Where this is not possible the buildings should be surveyed for nesting birds by a suitably qualified ecologist prior to works commencing. If they are found, then the nest and surrounding habitat must remain intact until the young have fledged. It should be noted that Feral Pigeons will breed all year if food supplies are plentiful.

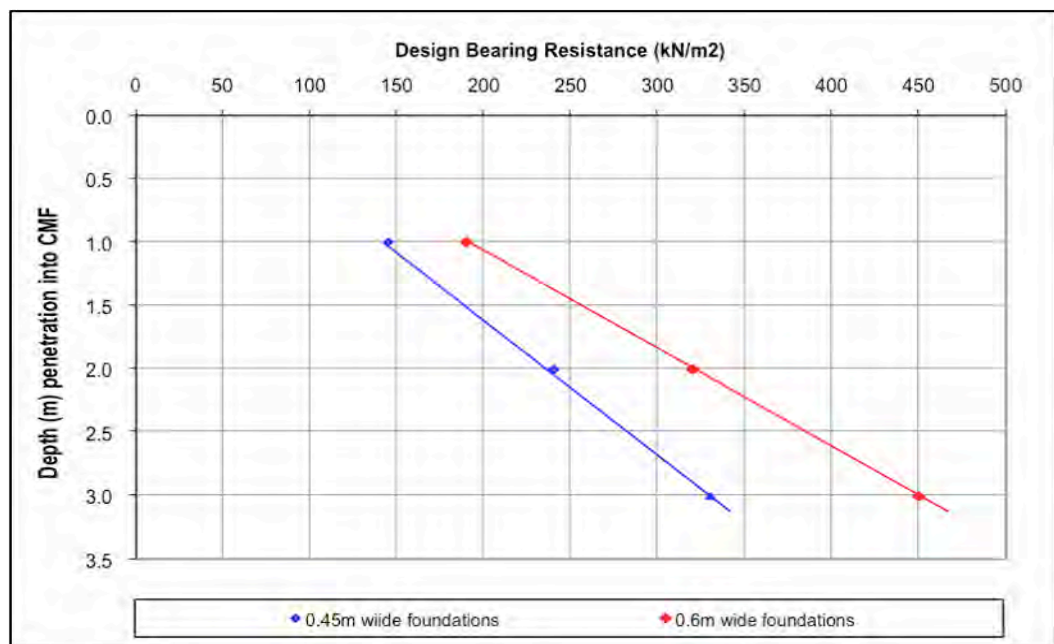
**FIG 4: DESIGN BEARING RESISTANCE -v- DEPTH OF PENETRATION INTO CMF**

- 6.8** In line with NHBC Standards (2014) Clause 4.2-S4 (a), heave protection in the form of compressible material should be provided against the inside faces of all external wall foundations greater than 1.5m deep (or around piles and under ground-beams) based on the appropriate tree height. On the same basis we recommend the site-wide adoption of fully suspended ground floor slabs for all plots, incorporating a sub-slab void of 225mm for pre-cast (block and beam) concrete, or 300mm for a timber floor.

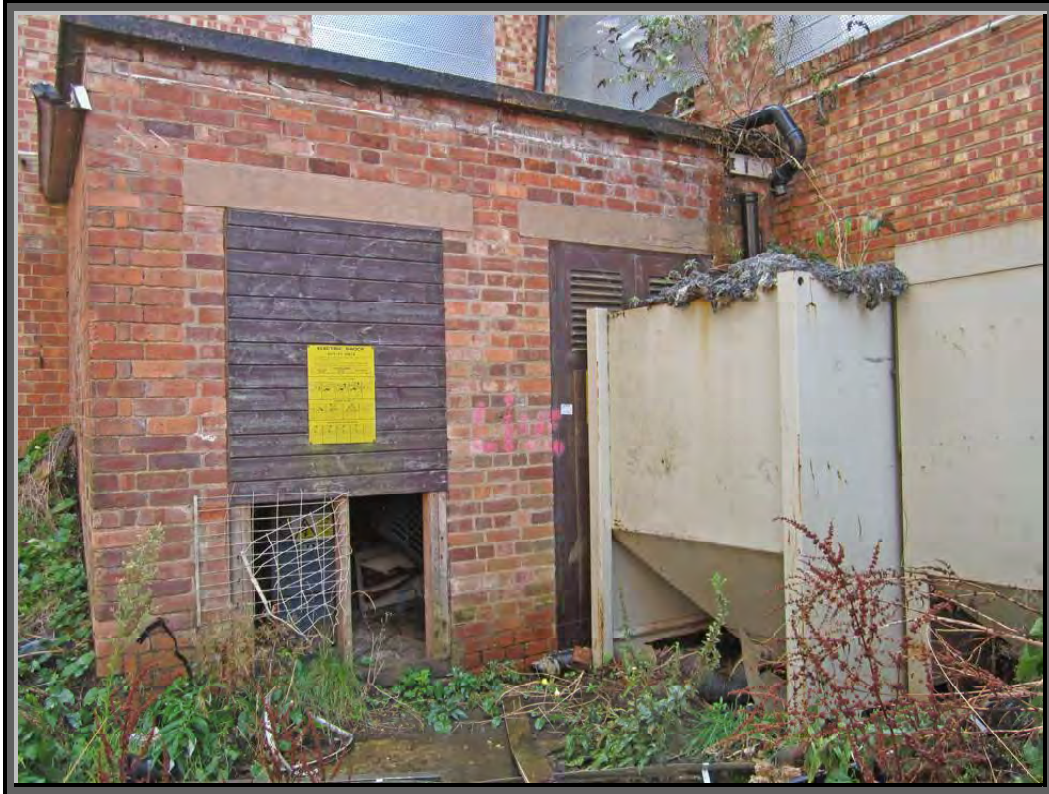
Photograph P7: showing redundant electricity sub-station

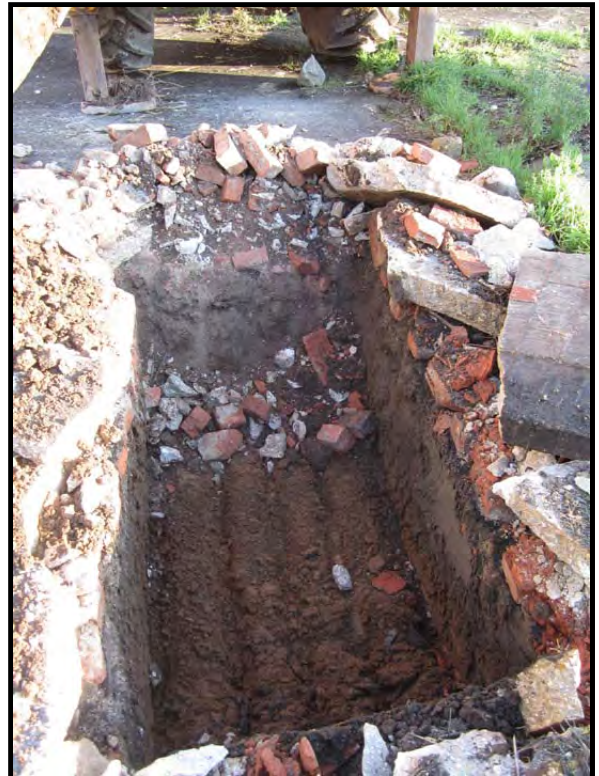
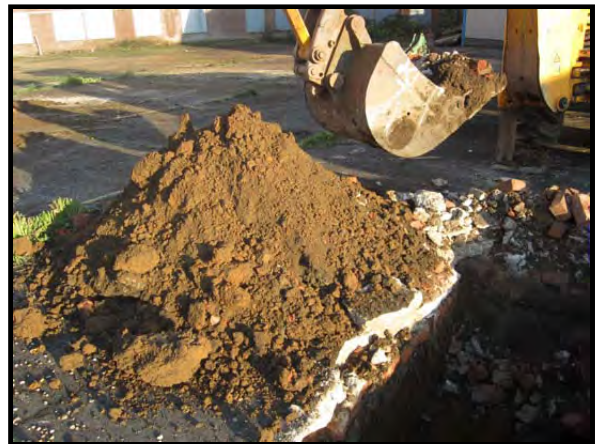
<b>Site:</b> FORMER NORVILLE WORKS, TARRINGTON ROAD, TREDWORTH, GLOUCESTER				<b>TRIAL PIT No.</b>
<b>Job No.</b> 3829	<b>Date</b> 18.11.14	<b>Ground Level (c.m, AOD)</b> 20.2m	<b>Co-Ordinates (c.)</b> E 383,920 N 217,147	<b>TP1</b>

- A CONCRETE: extremely strong/dense, former yard hardstanding; unreinforced
- B MADE GROUND: probable medium dense, medium to coarse, angular GRAVEL and COBBLES of whole and broken bricks and concrete
- C DISTURBED GROUND: firm/loose, mid grey, gravelly CLAY; gravel is fine to medium, subangular, black ash and brick
- D CLAY: firm, mid orangish-brown, sandy to very sandy with rare flecks of ?charcoal (*CHEL TENHAM SAND ?*)

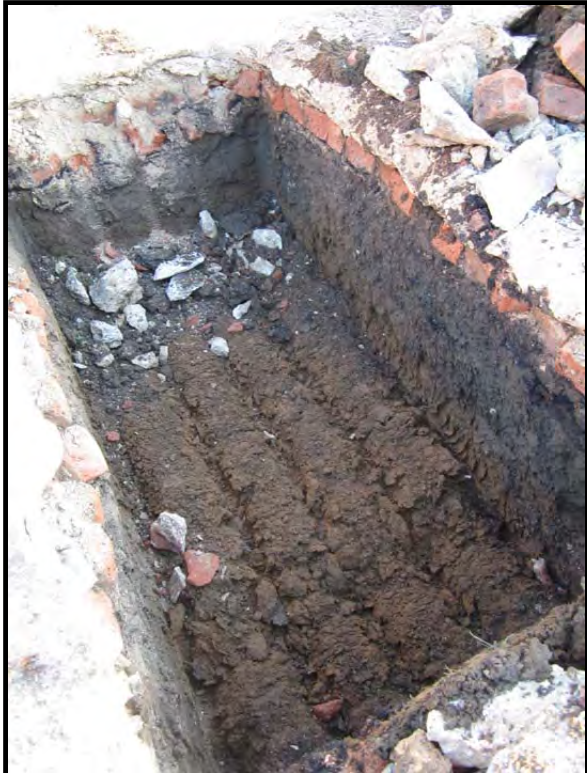
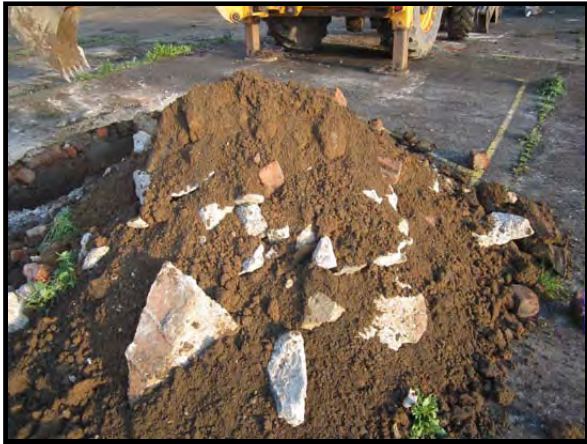
<b>Site:</b> FORMER NORVILLE WORKS, TARRINGTON ROAD, TREDWORTH, GLOUCESTER				<b>TRIAL PIT No.</b>
<b>Job No.</b> 3829	<b>Date</b> 18.11.14	<b>Ground Level (c.m, AOD)</b> 19.8m	<b>Co-Ordinates (c.)</b> E 383,925 N 217,162	<b>TP2</b>

- A CONCRETE: extremely strong/very dense, former yard hardstanding; unreinforced
- B BRICKS: single course of bricks, old floor or 'sub-base'
- C DISTURBED GROUND: loose, mid grey, gravelly and soily CLAY; gravel is fine to coarse, angular black ash, brick and rare pottery
- D CLAY/SAND: firm, mid orangish-brown, very sandy CLAY/loose very clayey SAND, occasional fine GRAVEL size flecks of black charcoal (*CHELTENHAM SAND ?*)

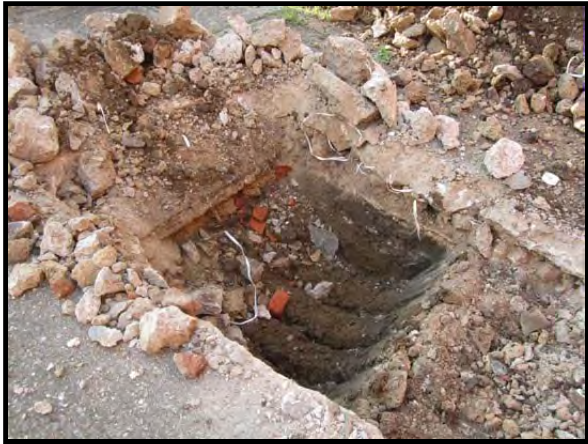
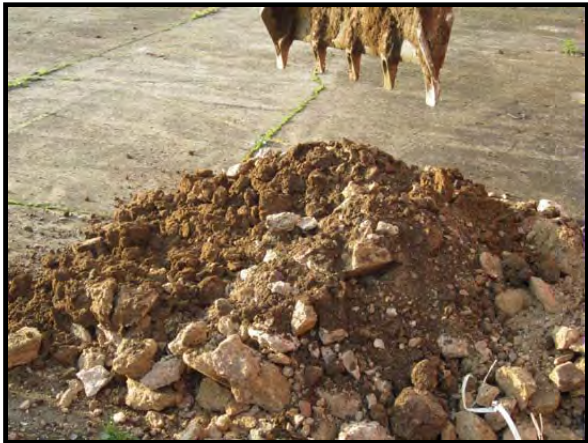
<b>Site:</b> FORMER NORVILLE WORKS, TARRINGTON ROAD, TREDWORTH, GLOUCESTER				<b>TRIAL PIT No.</b>  <b>TP3</b>
<b>Job No.</b> 3829	<b>Date</b> 18.11.14	<b>Ground Level (c.m, AOD)</b> 19.4m	<b>Co-Ordinates (c.)</b> E 383,930 N 217,174

- A CONCRETE: extremely strong/dense, former yard hardstanding; unreinforced
- B MADE GROUND: probable medium dense, light grey, fine to coarse GRAVEL of concrete, mortar and brick with rare ash and rusty metal
- C CLAY/SAND: probable firm, mid brown, very sandy CLAY/medium dense, very clayey, quartzitic medium SAND, rare flecks of black charcoal  
*(CHELTENHAM SAND ?)*

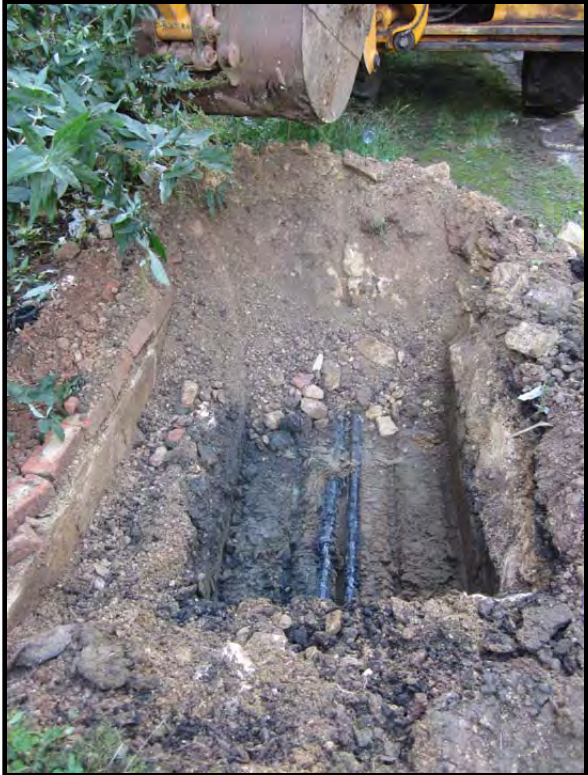
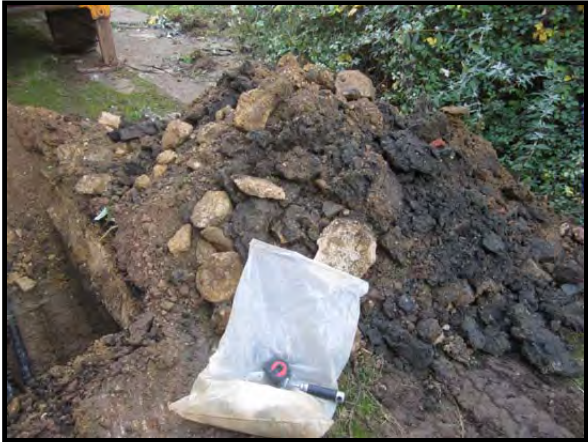
twin 45mm diameter  
?redundant electricity  
cables in narrow  
trench

- A **MADE GROUND:** probable medium dense, whole and broken bricks, and angular **COBBLES** of cream limestone, in light brown limestone and mortar matrix
- B **BRICKWORK:** very dense old foundations
- C **CLAY:** probable firm, light brown, plastic and silty, flecks of black charcoal (*ALLUVIUM ?*)

- 1 Pit logged from surface
- 2 Pit dry and stable
- 3 Soil samples taken at 0.0-0.35m, and 0.35-0.75m depth

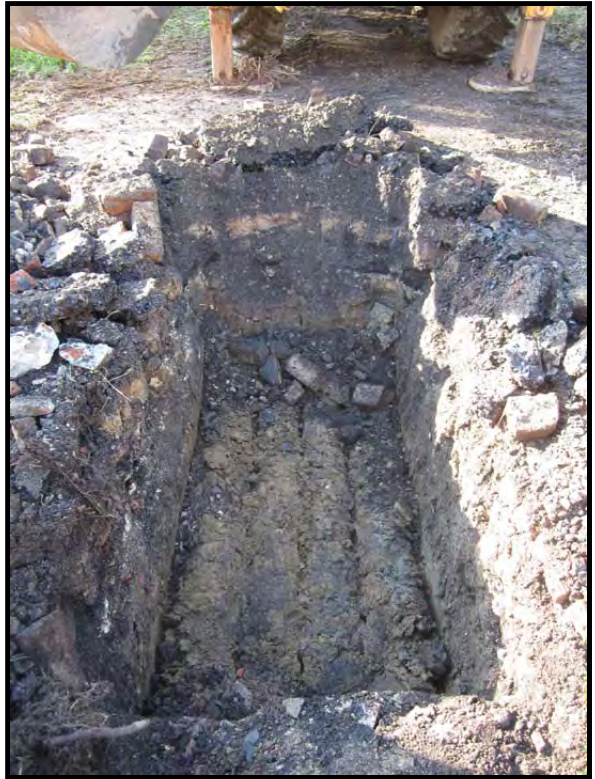
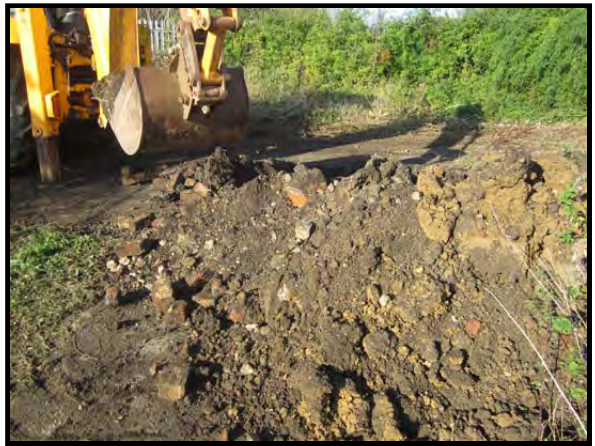
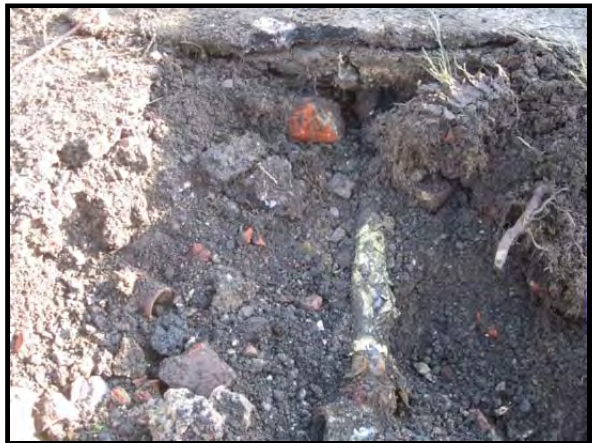
60mm diameter  
redundant ?gas  
main (yellow  
coated steel) -  
already broken

- A TARMAC: probable very dense/strong, former hardstanding
- B MADE GROUND: probable dense, COBBLES of whole and broken bricks in GRAVEL of fine to medium, dark grey/black ash, rare broken glass and rusty metal
- C CLAY: probable firm, light brown, slightly silty, occasional flecks of charcoal (*ALLUVIUM ?*)

- 1 Pit logged from surface
- 2 Pit dry and stable
- 3 Soil samples taken at 0.1-0.5m, and 0.7-0.9m depth

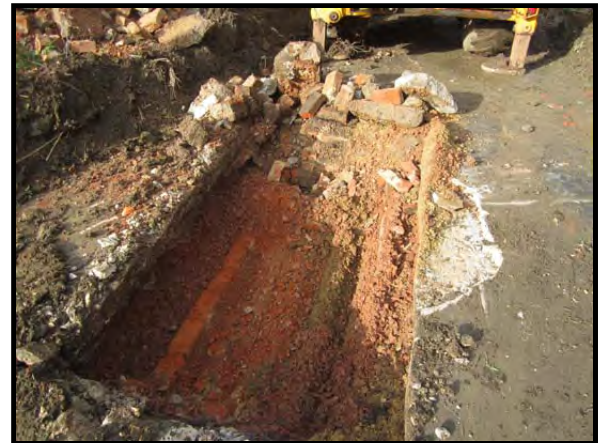
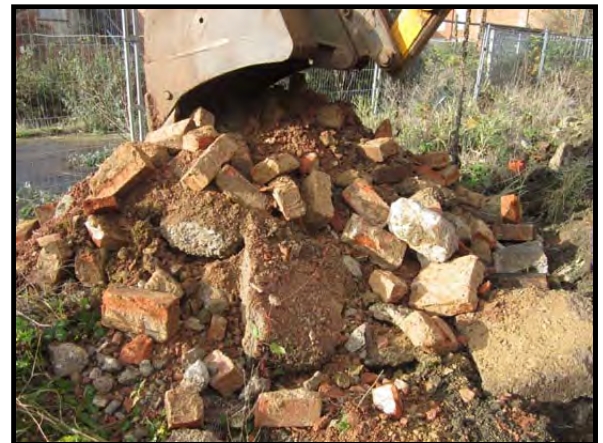
<b>Site:</b> FORMER NORVILLE WORKS, TARRINGTON ROAD, TREDWORTH, GLOUCESTER				<b>TRIAL PIT No.</b>  <b>TP6</b>
<b>Job No.</b> 3829	<b>Date</b> 18.11.14	<b>Ground Level (c.m, AOD)</b> 18.7m	<b>Co-Ordinates (c.)</b> E 383,018 N 217,112

- A CONCRETE: extremely strong former floor slab; unreinforced
- B MADE GROUND: loose, angular, medium and coarse GRAVEL of light reddish-brown crystalline limestone (sub-base)
- C BRICKWORK: intact former foundation – very difficult to excavate
- D CLAY: probable firm, light brown, slightly sandy CLAY  
(*ALLUVIUM* ?)

- 1 Pit logged from surface; aborted due to difficulty of excavating old foundations
- 2 Pit dry and stable
- 3 Soil samples taken at 0.25m, and 0.5m depth

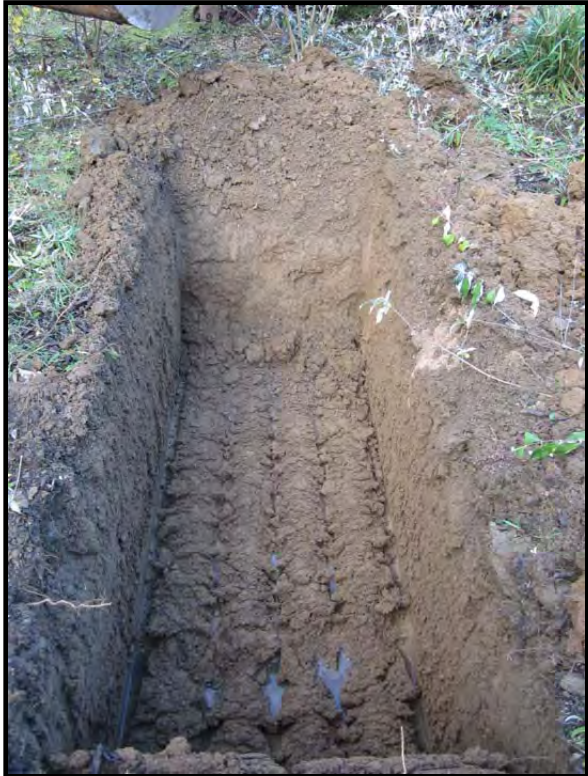
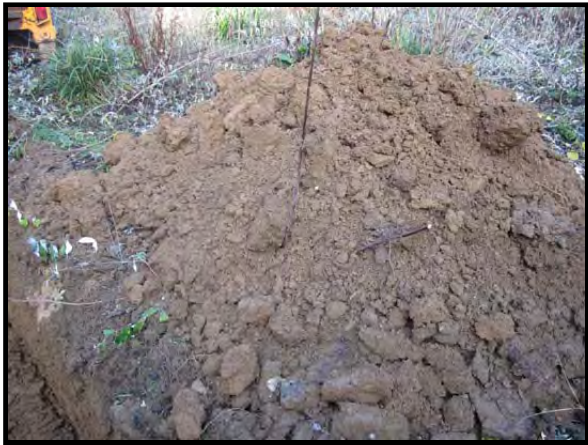
<b>Site:</b> FORMER NORVILLE WORKS, TARRINGTON ROAD, TREDWORTH, GLOUCESTER				TRIAL PIT No.
<b>Job No.</b> 3829	<b>Date</b> 18.11.14	<b>Ground Level (c.m, AOD)</b> 18.5m	<b>Co-Ordinates (c.)</b> E 383,001 N 217,107	<b>TP7</b>

- A TOPSOIL: probable soft, dark brown, very soily CLAY, and leaf litter (poorly developed)
- B CLAY: probable firm, light brown, silty and plastic; occasional rootlets from overlying cover of buddleia bushes and weeds; occasional flecks of black charcoal  
*(ALLUVIUM ?)*

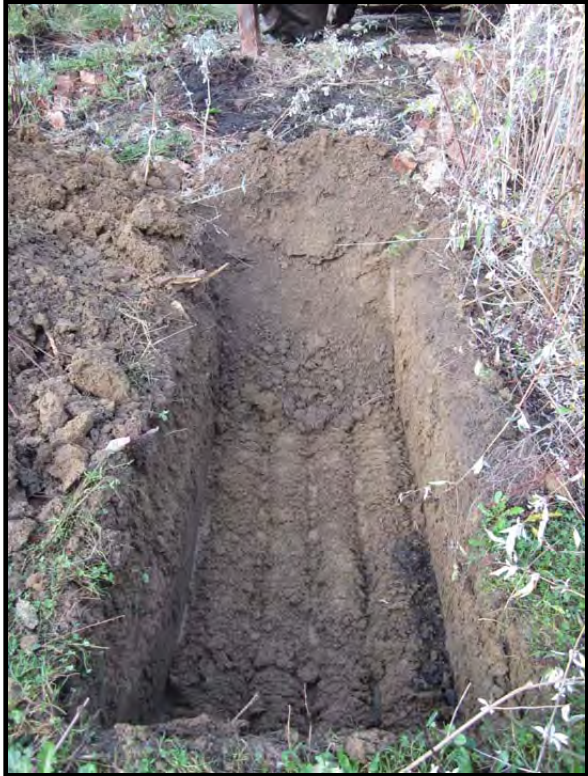
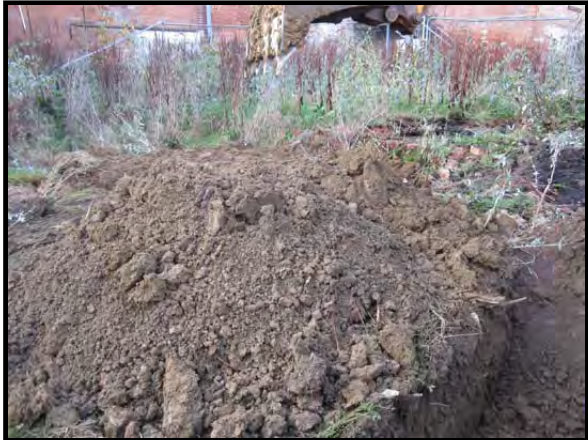
<b>Site:</b> FORMER NORVILLE WORKS, TARRINGTON ROAD, TREDWORTH, GLOUCESTER				<b>TRIAL PIT No.</b>  <b>TP8</b>
<b>Job No.</b> 3829	<b>Date</b> 18.11.14	<b>Ground Level (c.m, AOD)</b> 18.5m	<b>Co-Ordinates (c.)</b> E 383,992 N 217,102

- A TOPSOIL: (poorly developed) probable soft, dark brown, slightly organic silty CLAY
- B CLAY: probable firm, light brown, silty and plastic; slight seepage from 0.85m

- 1 Pit logged from surface
- 2 Pit generally dry (slight seepage at/from 0.85m; stable)
- 3 Soil sample taken at 0.0-0.25m depth

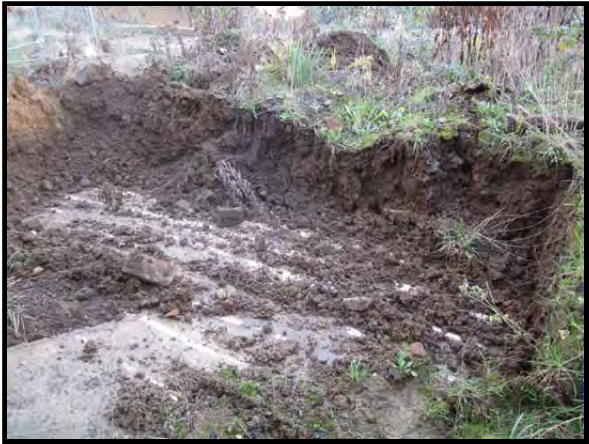
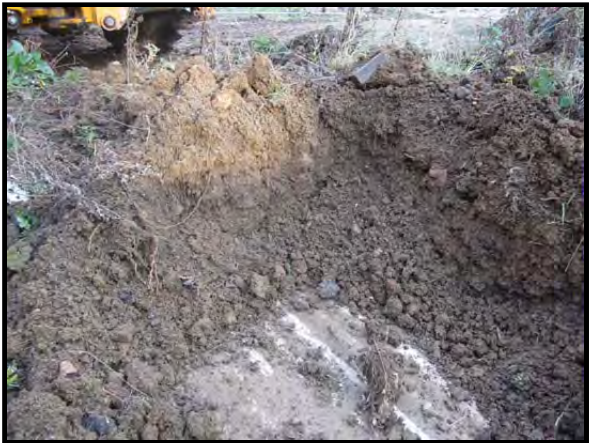
<b>Site:</b> FORMER NORVILLE WORKS, TARRINGTON ROAD, TREDWORTH, GLOUCESTER				<b>TRIAL PIT No.</b>  <b>TP9</b>
<b>Job No.</b> 3829	<b>Date</b> 18.11.14	<b>Ground Level (c.m, AOD)</b> 19.0m	<b>Co-Ordinates (c.)</b> E 383,983 N 217,115

- A **MADE GROUND:** firm, light brown, gravelly and soily CLAY (gravel is coarse COBBLES of brick and concrete)
- B **CONCRETE:** extremely strong, former floor slab, unreinforced

- 1 Pit logged from surface
- 2 Pit dry and stable
- 3 Soil samples taken at 0.0-0.4m depth

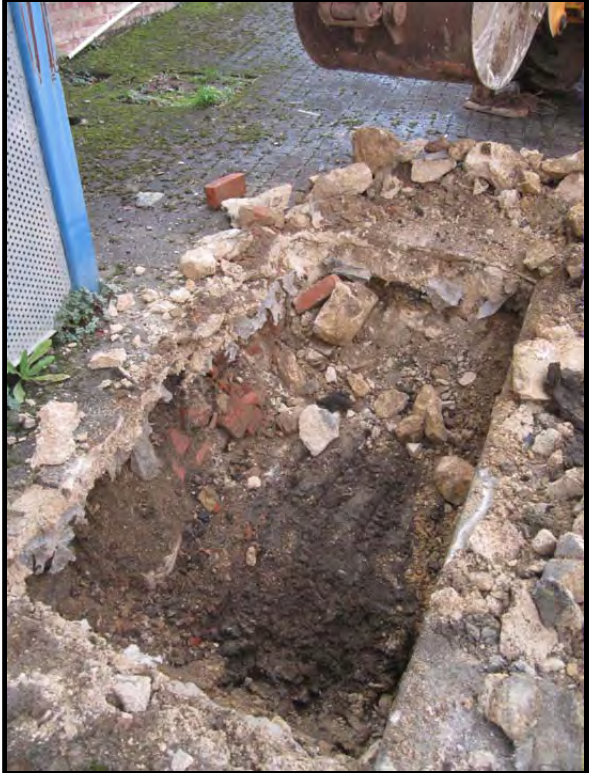
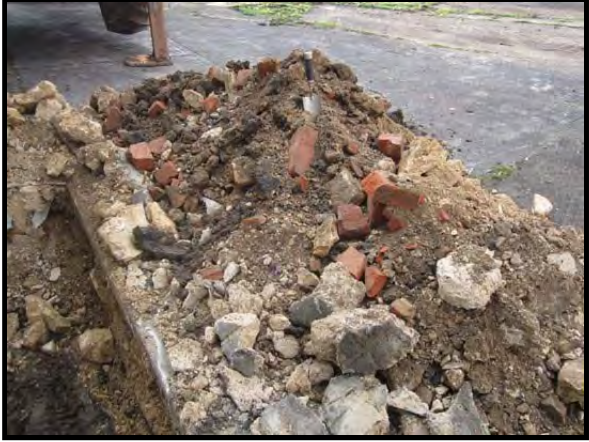
<b>Site:</b> FORMER NORVILLE WORKS, TARRINGTON ROAD, TREDWORTH, GLOUCESTER				<b>TRIAL PIT No.</b>
<b>Job No.</b> 3829	<b>Date</b> 18.11.14	<b>Ground Level (c.m, AOD)</b> 20.0m	<b>Co-Ordinates (c.)</b> E 383,938 N 217,150	<b>TP10</b>

- A CONCRETE: extremely strong/very dense, former yard hardstanding (unreinforced, basal polythene sheet)
- A1 CONCRETE: former foundation ?
- B MADE GROUND: probable loose to medium dense, fine to coarse, angular soily GRAVEL and COBBLES of cream limestone, whole and broken bricks
- C CLAY: probable firm, mid to dark grey-brown, silty with flecks of black charcoal (*ALLUVIUM ?*)

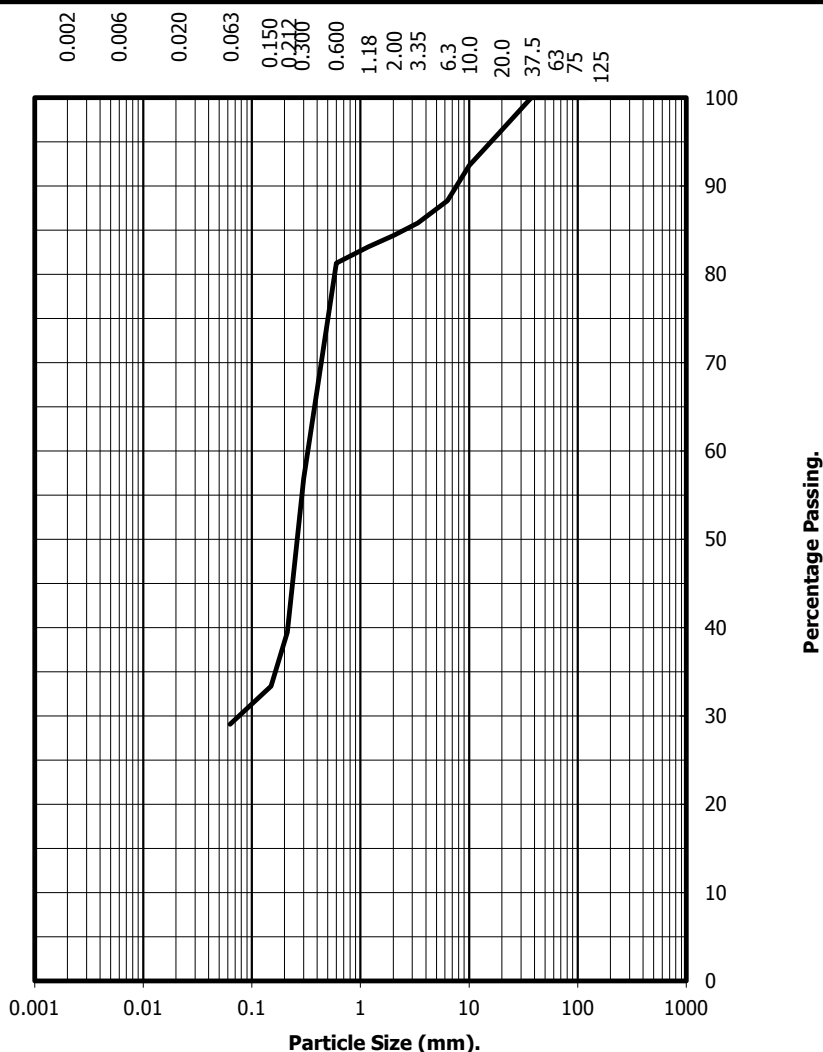
Particle Diameter	Percentage Passing
0.02	#
0.006	#
0.002	#

Silt and Clay	Sand	Gravel	Cobbles	Soil Fraction
	29	55	16	0	Total Percentage

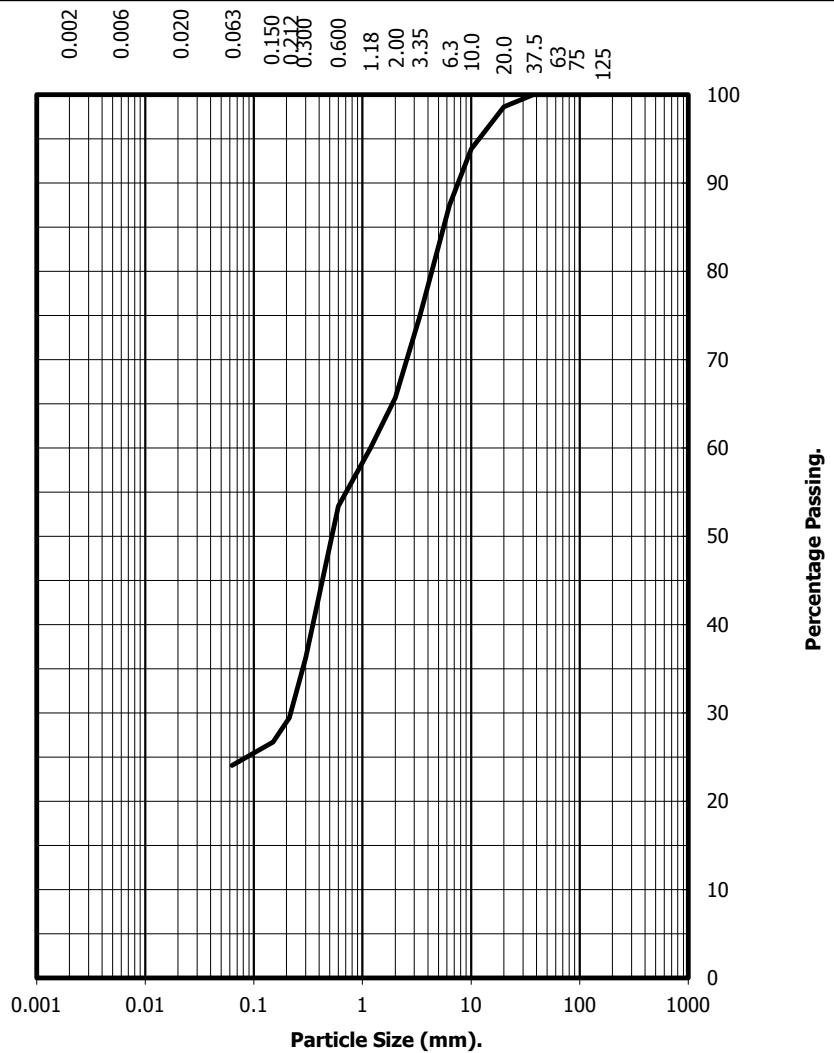
Silt and Clay	Sand	Gravel	Cobbles	Soil Fraction
	24	42	34	0	Total Percentage
